**MONITORING FOR SUCCESS IN STREAM RESTORATION: A CASE STUDY OF  
THE KAMA CREEK, NORTH SHORE OF LAKE SUPERIOR**

A Thesis Submitted to Lakehead University in Partial Fulfillment of the  
Thesis requirements for the degree of  
Master of Environmental Studies in Northern Environments and Cultures  
in the departments  
of  
Anthropology and Geography

May 2015

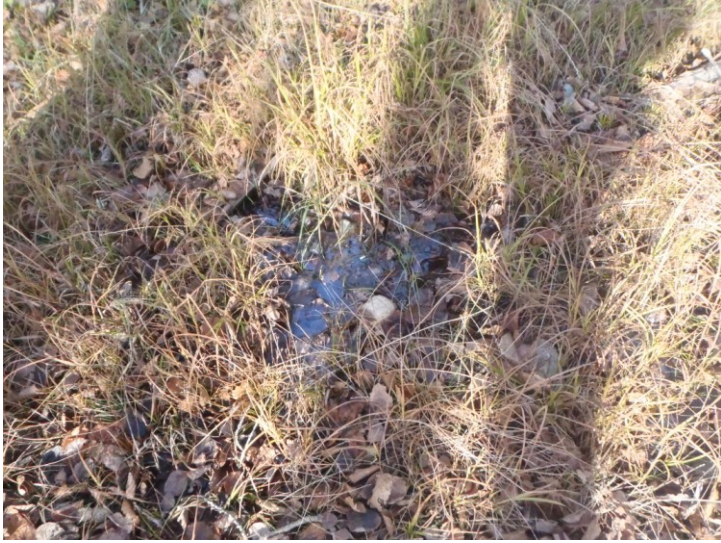
Figure 4.2a Groundwater seep located on the bank of newly restored reach of Kama Creek.

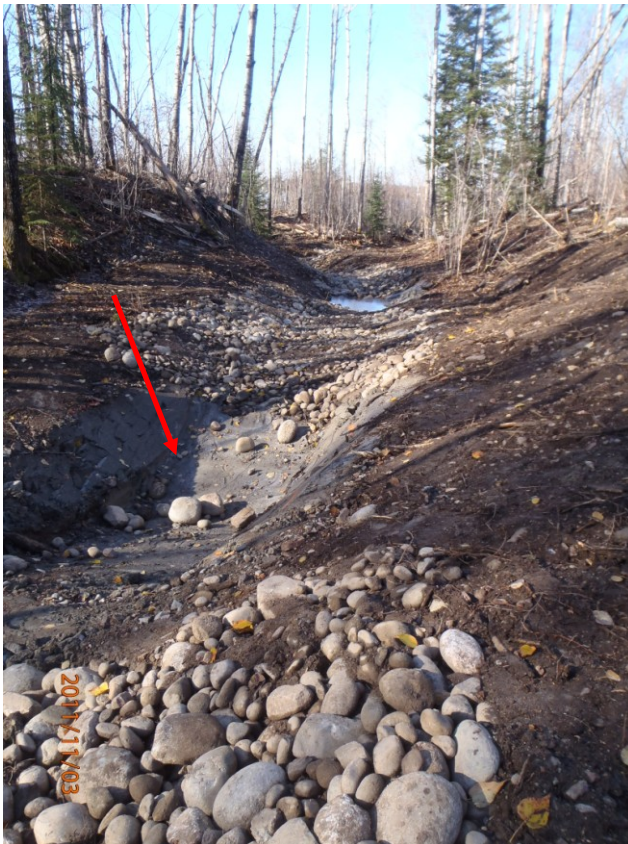
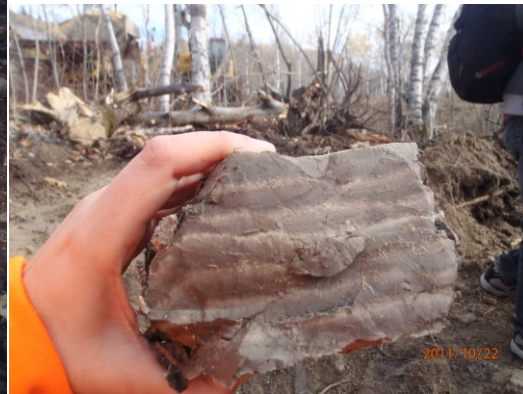
Figure 4.2b and c. Photos of clay bottom found when excavating reach 2 of Kama Creek. Arrow points to thick clay layer in pool of new channel (left). On the right, section of clay showing layering.

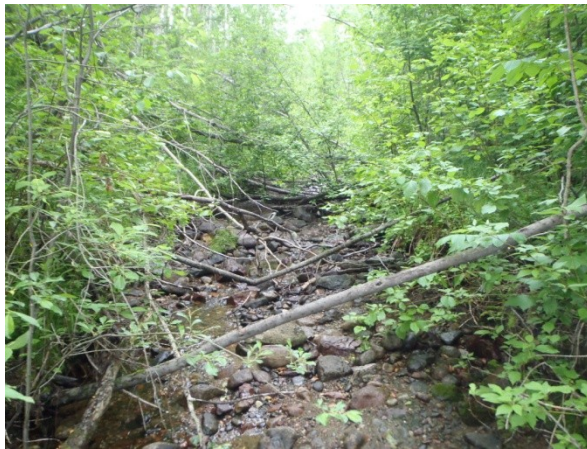
In 2011, reach 1 showed an optimal amount of available cover with many fallen logs and large woody debris (Figure 4.3a). It was given a rating of 20 for most optimal epifaunal substrate and available cover (Table 4.1) because greater than 50% of the substrate was favorable for epifaunal colonization and fish cover. In 2012 the newly restored channel (reach 2) was rated as poor conditions for available cover. This was due to a lack of cover directly after construction (Figure 4.3b). In 2014, reach 2 established a variety of natural structures in the stream, such as cobble (riffles), large rocks, fallen trees, logs and branches, and undercut banks. These features provide refugia, feeding sites, and sites for spawning and nursery from the establishment of aquatic macrofauna (Figure 4.3c). These factors increased the rating to 11 at the low end of suboptimal habitat.

Figure 4.3a. Reach 1 Showing optimal cover in 2011. Figure 4.3b. Reach 2 2012 showing minimal cover

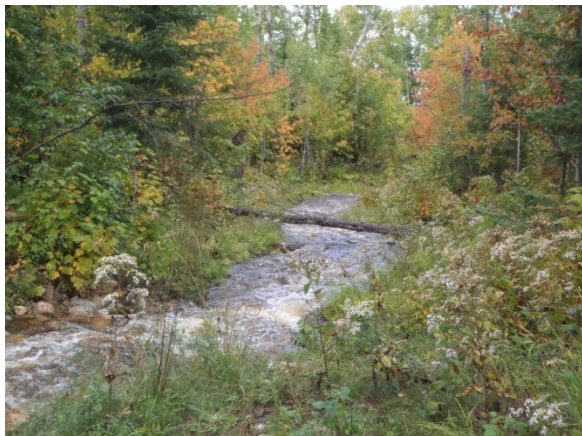
Figure 4.3c. Reach 2 in 2014 showing improvements in cover compared to 2012.

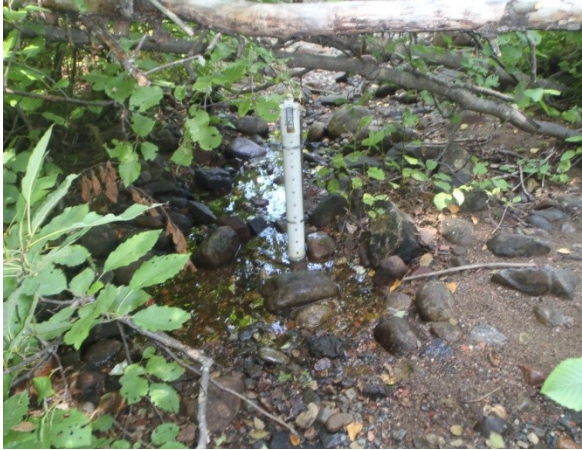
Figure 4.4a. Reach 1 in 2011 showing optimal substrate. Figure 4.4b. Reach 2 in 2012 showing poor substrate with mud and clay dominant and no submerged vegetation.

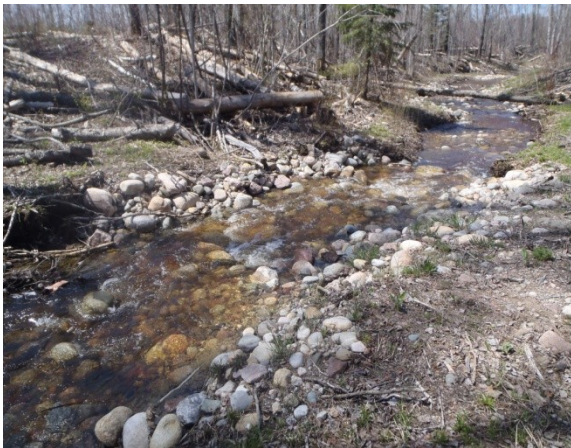
Figure 4.4c. Reach 2 in 2014 showing slight improvements in pool substrate characterization.

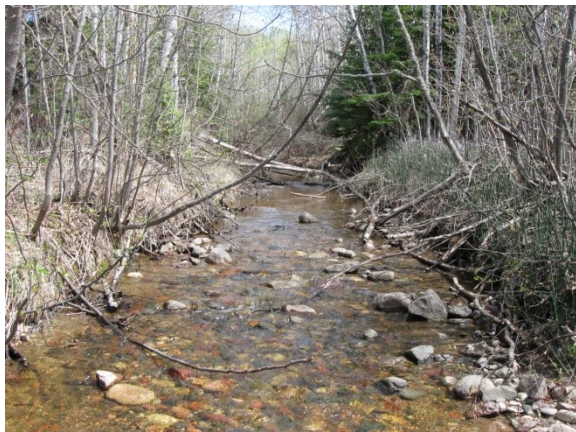
Figure 4.8a. Marginal in the old channel in 2011 with few shallow pools present.

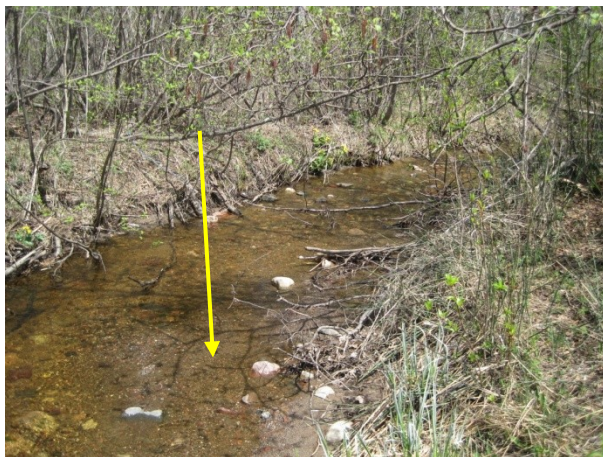
Figure 4.9a. Arrow shows sediment deposition in old channel in 2011

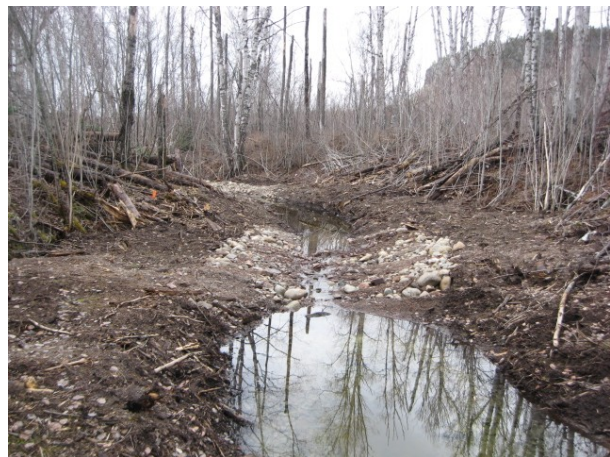
Figure 4.9b. Little deposition in 2012 as channel was freshly dug

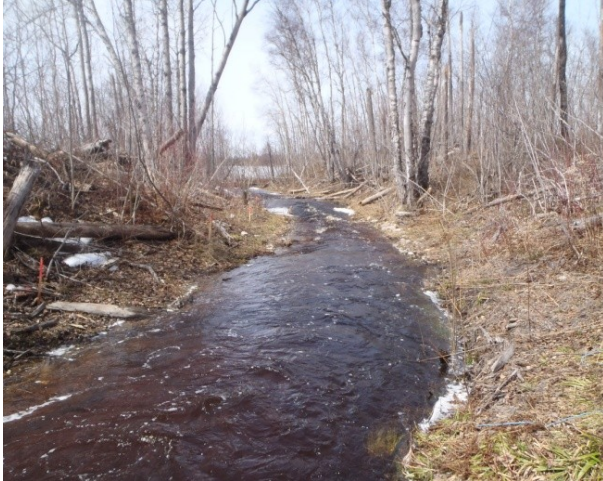
Figure 4.9c. Reach 2 in 2014 starting to show sediment deposition

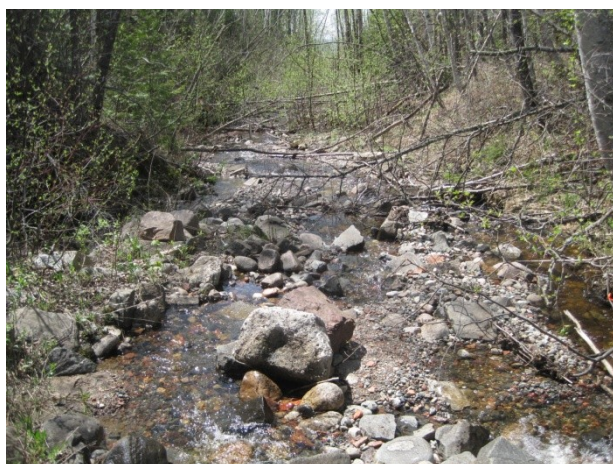
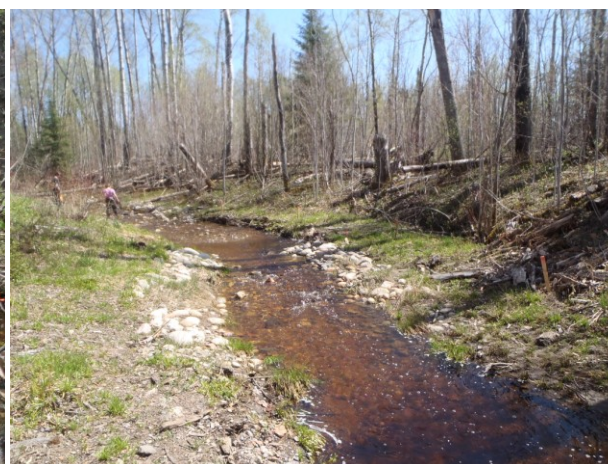
Figure 4.10a. 2011 Marginal channel flow status

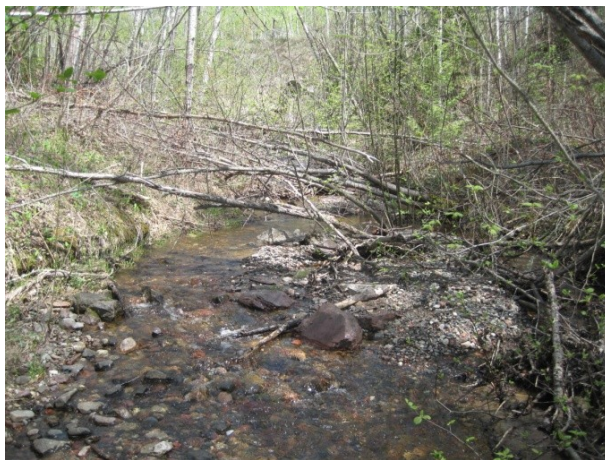
Figure 4.12a. Occasional riffles present in 2011.

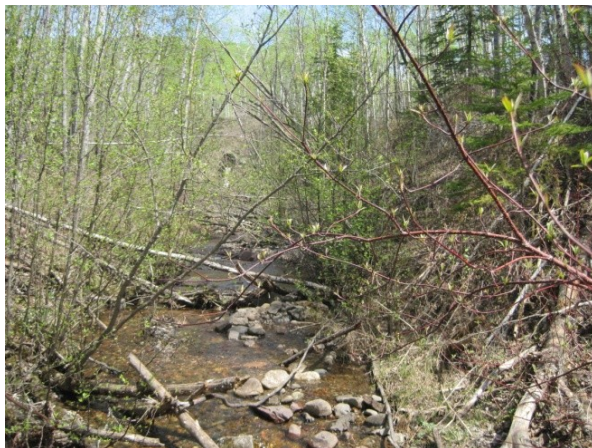
Figure 4.13b. Old channel dredged in the 1960 for the railway.

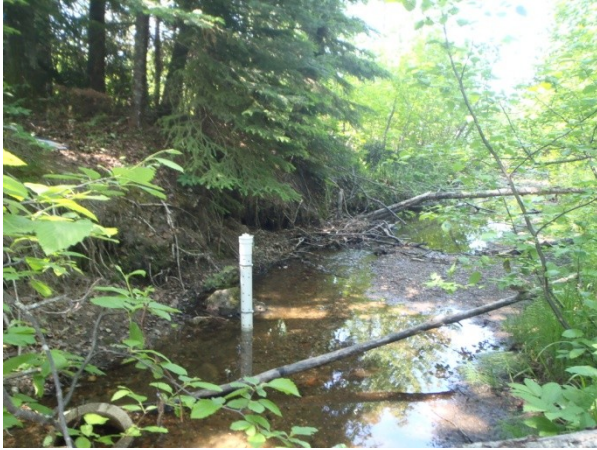
Figure 4.14a. 2011 old channel showing steep eroded banks.

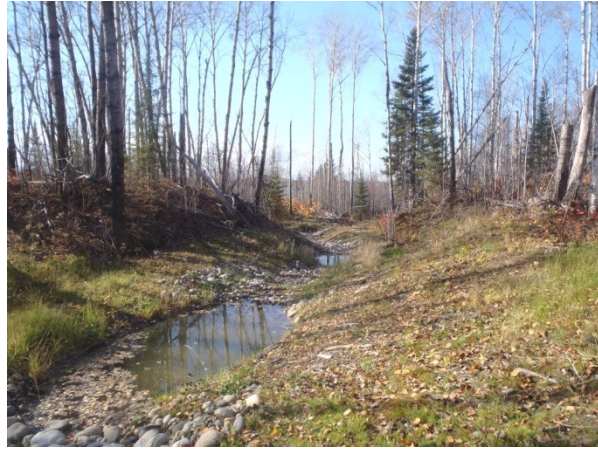
Figure 4.14b. 2012 new channel showing little erosion on banks.

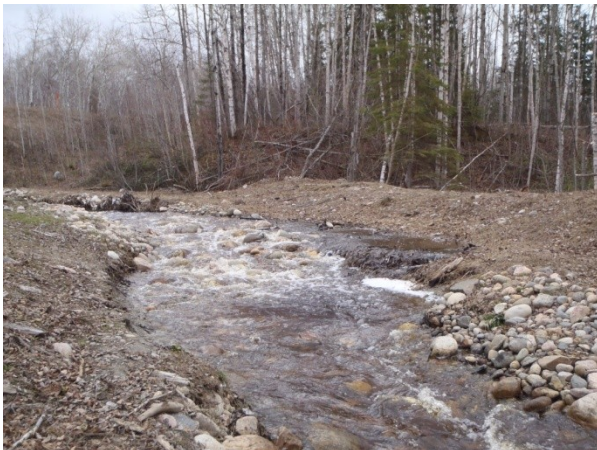
Figure 4.14c. 2014 new channel showing erosion of banks.

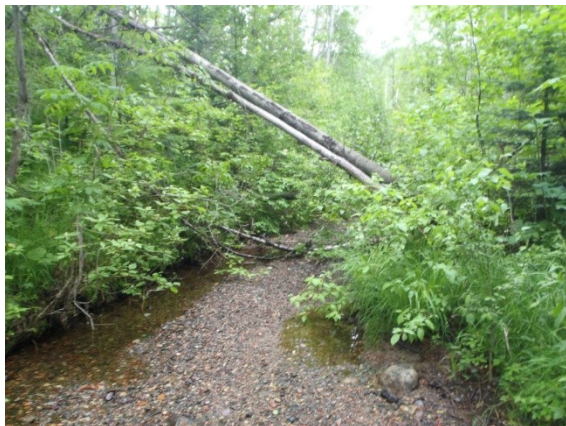
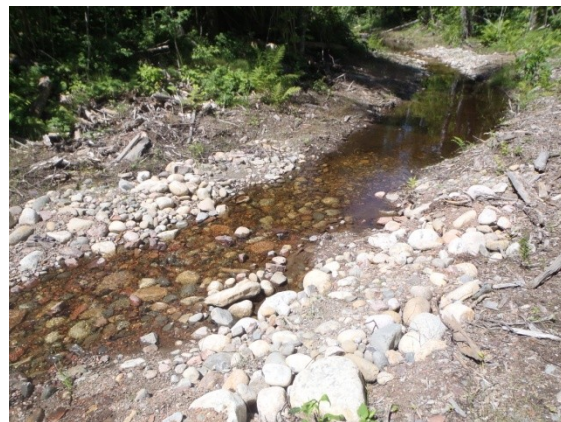
Figure 4.15a. Photo shows optimal vegetation in 2011. Figure 4.15b. In 2012 vegetation not yet grown.

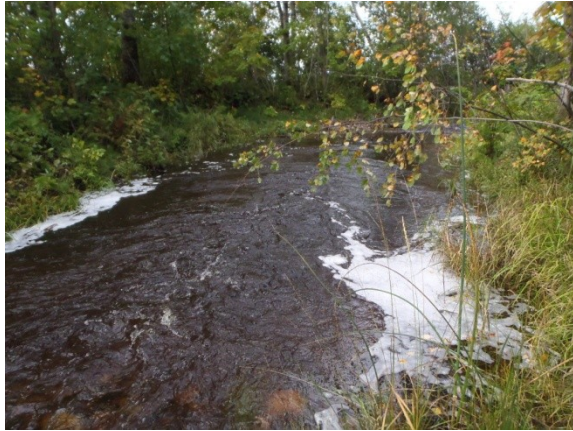
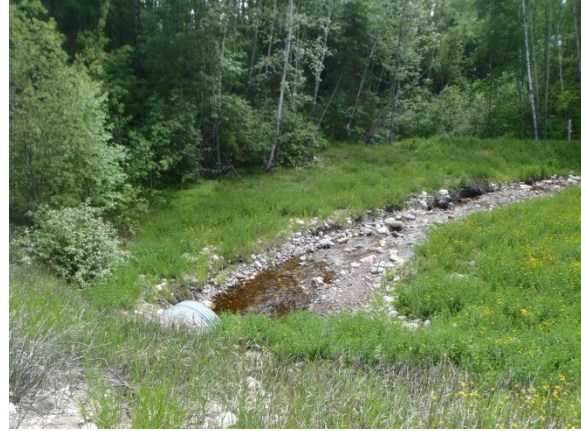
Figure 4.15c. and d. By 2014 vegetation has already grown thick along bank of new channel.

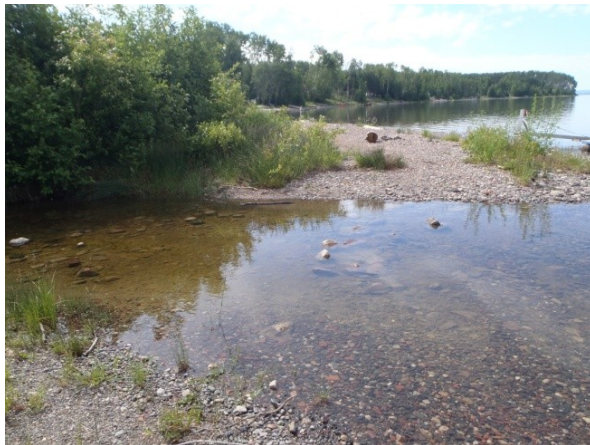
Figure 4.16a. Cabins along the shore are affecting the riparian zone.
