CULVERT INSTALLMENT AND REMOVALS, HOW THEY AFFECT
SURROUNDING HABITAT AND HOW WE CAN IMPROVE OUR METHODS OF
MAINTENANCE

FACULTY OF NATURAL RESOURCES MANAGEMENT
LAKEHEAD UNIVERSITY
THUNDER BAY, ONTARIO

An Undergraduate Thesis Submitted in
Partial Fulfillment of the Requirements for the
Degree of Honours Bachelor of Environmental Management

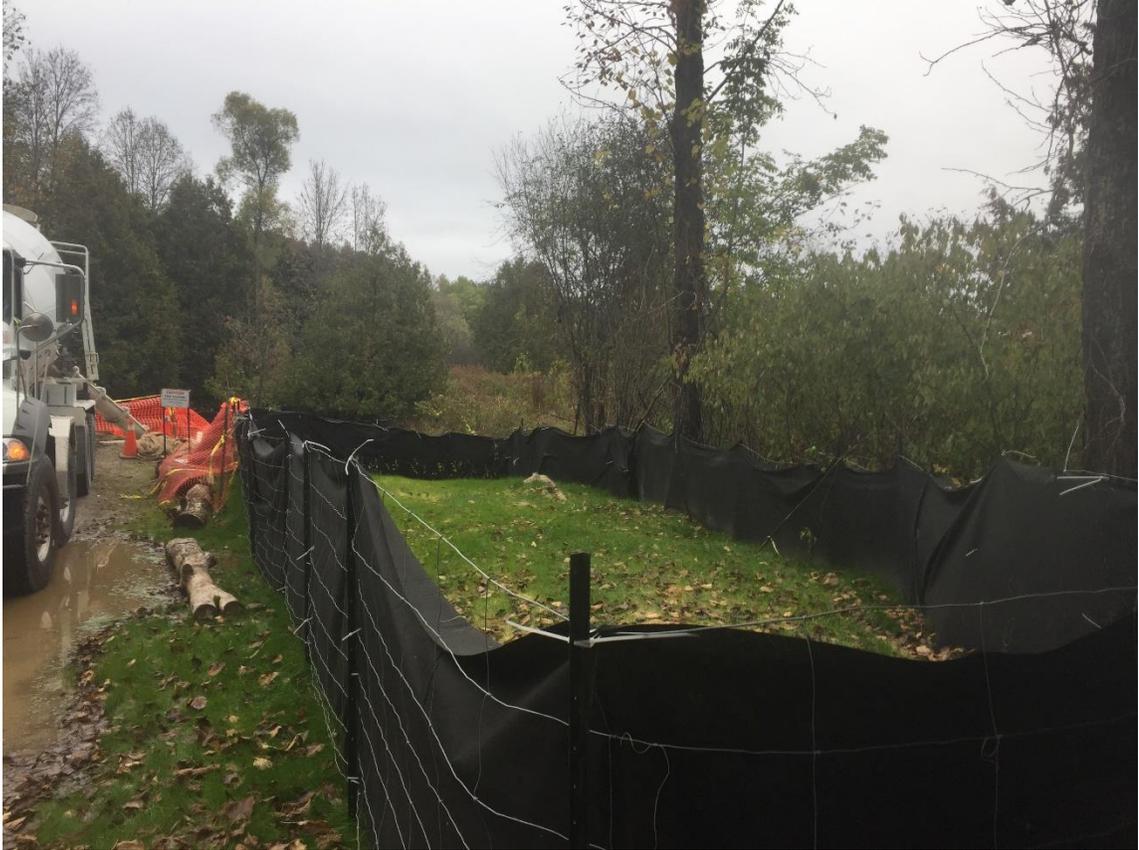
Figure 7. Riparian preservation with silt fences (Ewaskie 2018)

Silt fencing was used to protect wildlife areas around the culvert extraction site. Figure 7 shows just one area where this barrier was used. Silt fencing was used to protect stream flow on both the inlet and the outlet portion of the culvert to not disrupt the flow even further.

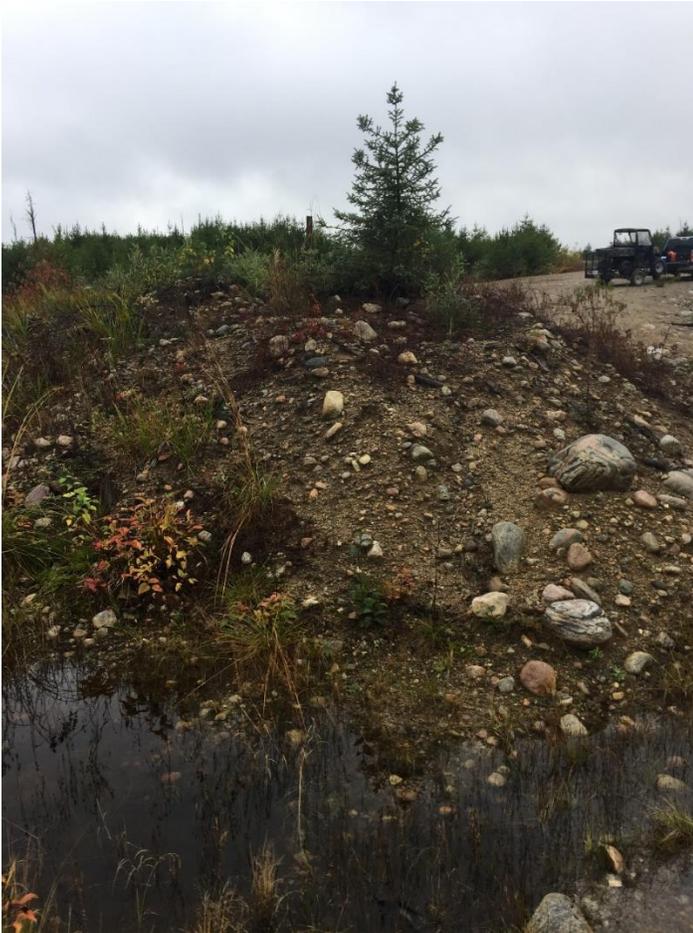
Figure 10. First culvert extraction site (Ewaskiw 2017)

The first plot that was examined was on an active road, leading to a deactivated road on the other side of the culvert extraction area. The soil type was primary cobble, organic mater and gravel surrounded by marshland. There was a standing stream present and it was about 0.5ft deep with high amount of vegetation in and around the area. Soil compaction was around $1.5\text{kg}/\text{cm}^2$. There was deep trenching on this site, no ground evidence of animal life, only the calls of songbirds were present, as shown in appendix 6.

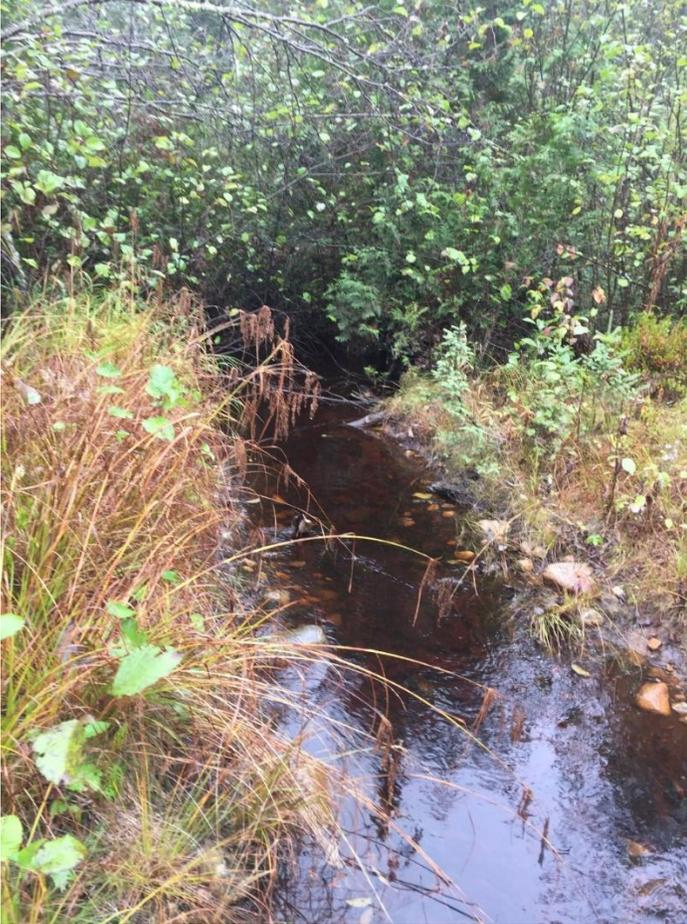
Figure 11. Second culvert extraction site (Ewaskiw 2017)

The second plot that was evaluated was on a running stream on a one-sided active road, upon reaching the site, vegetation begins to overtake the road about 25 meters before entering the stream. There is low trenching with a soil type of loamy sand. Soil compaction was around $3.0\text{-}2.5\text{kg}\cdot\text{cm}^2$. The road leading up to the culvert was about 6m across. The stream is intermitted and contains algae, sand, and rocks with no aquatic life as shown in appendix 3. This location had a high amount of song bird activity, as well as evidence of squirrels and moose tracks (both older moose and caff). This sight also had the most amount of vegetation out of all three of the sites examined.

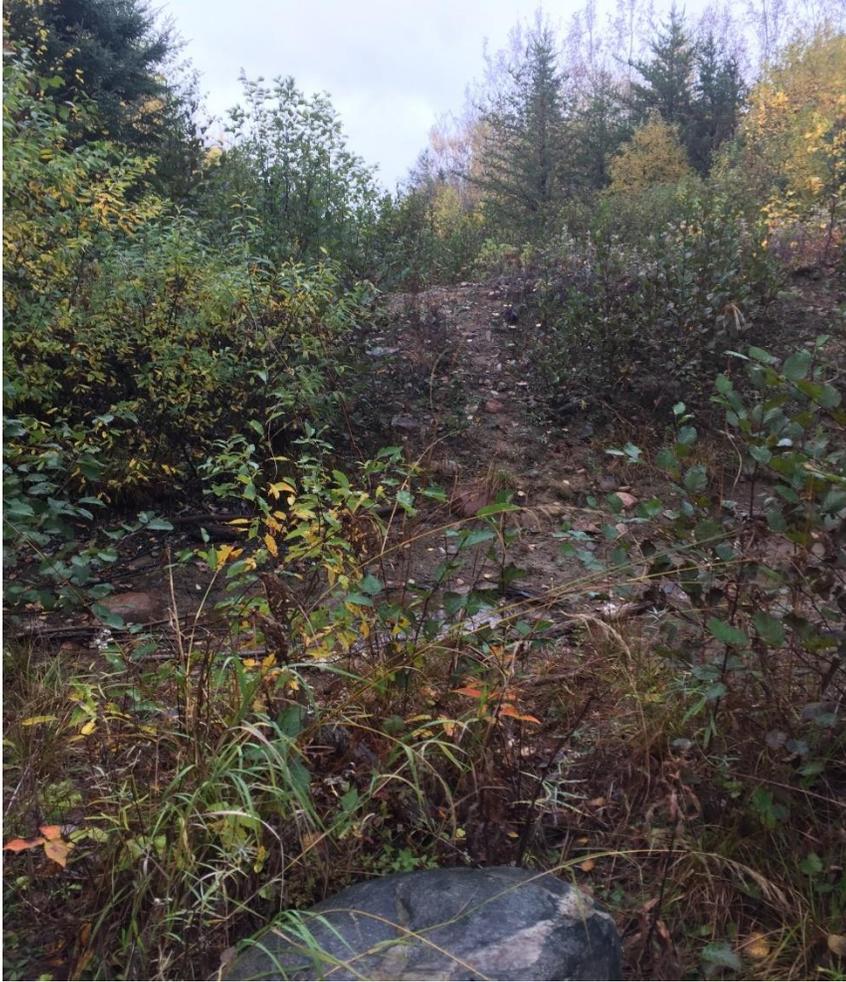
Figure 12. Third culvert extraction site – CONTROL (Ewaskiw 2017)

The third culvert site acted as a control for examining the landscape after a culvert removal. It sits in a lowland area on a fully deactivated road with very little regeneration as shown in appendix 2. There is no running water in the area, as well as a high amount of living native vegetation. The soil type is sandy, gravel, and clay with a compaction of $2.5-3.5\text{kg/cm}^2$. The stream was dry and alienated with rocks. There is high evidence of animal life around the culvert area, such as song birds, moose scat, moose tracks and wolf tracks. Hidden camera footage provided by the second reader - Ryan Wilkie, provided evidence of black bears using this area for foraging and habitat linkage.
