A Physical and Spatial Assessment of Remediated Submerged Habitats within the Thunder Bay Area of Concern

Thesis completed in partial fulfillment of a Masters in Environmental Studies.

Lakehead University

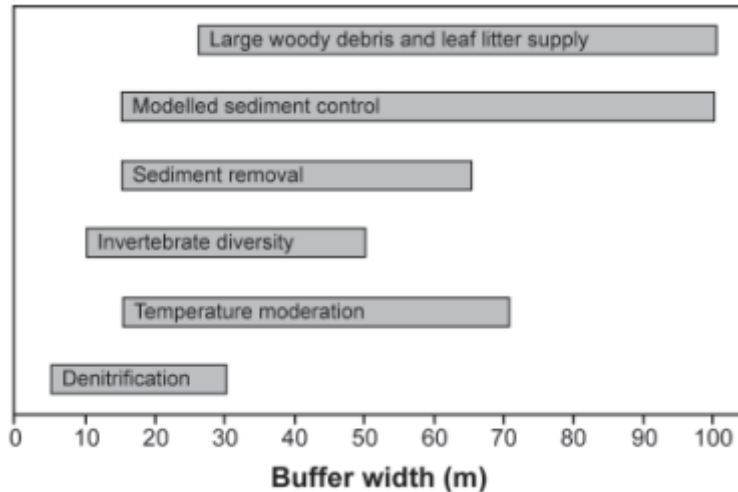
Figure 3: Buffer Width Recommendations (Broadmeadow and Nisbet, 2004).

The required extent of a buffer zone will vary depending on the aquatic habitat type, landscape context, and hydrological regimes (Pusey and Arthington, 2003; Lee et al., 2004). The intensity of adjacent land uses will influence the ideal range (EC, 2013). There is no one effective buffer width, but buffer zones ranging from 30m to 60m were usually sufficient to support ecological interactions and mitigate the magnitude of potential stressors (Broadmeadow and Nisbet, 2004; EC, 2013). The varying buffer requirements for achieving adequate performance of specified habitat functions can be seen in Figure 3. Linkages between riparian zones and aquatic habitat should be an essential consideration when rehabilitating degraded environments and in preventing further deterioration (Pusey and Arthington, 2003). When planning and executing a remedial action plan, high emphasis should be placed on maintaining biologically meaningful buffers for wetlands and riparian habitats (RAP, 2012).

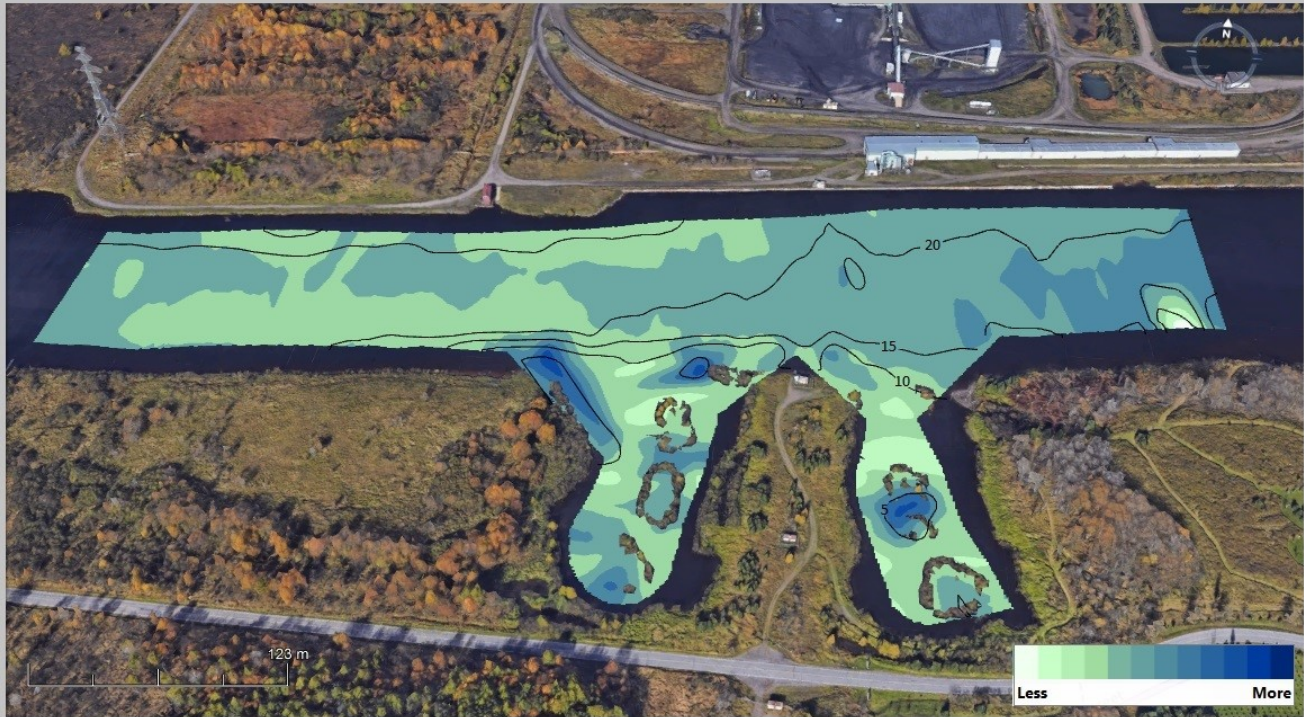
McKellar Embayments Bottom Composition E2 Relative Hardness Eco Return

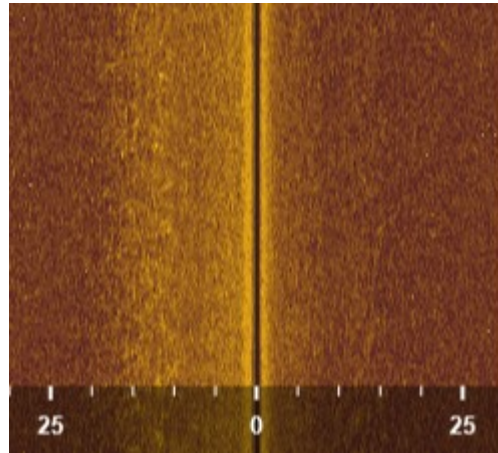
Figure 28: Side Scan Sonar of Fine Substrate.

The river channel had a maximum depth of 10ft with fairly straight channel walls (Figure 28). The channel had grassy banks with silty-sand sediment (in-field visual reference), transitioning to a fine-grained packed silty-clay substrate in the middle of the channel (Figure 28). Sonar imagery and ground-truthing confirmed a silty-clay composition mid-channel as indicated by the darker sonar returns and texture (Figure 28). Bottom composition profiles (Figure 30) had lighter colored hardness returns, indicative of a softer substrate, with some compaction increasing the hardness level. The low volumes of macrophyte biomass lead to active resuspension of the small particulates, contributing to higher turbidity levels in the river and within the delta. The embayment features, including the bolder pilings, wood pilings, and log mats described within the rehabilitation plans, did not stand out on the surface of the water and were not distinctive on the side-scan sonar imagery as indicated in the original rehabilitation plans (Figure 29).

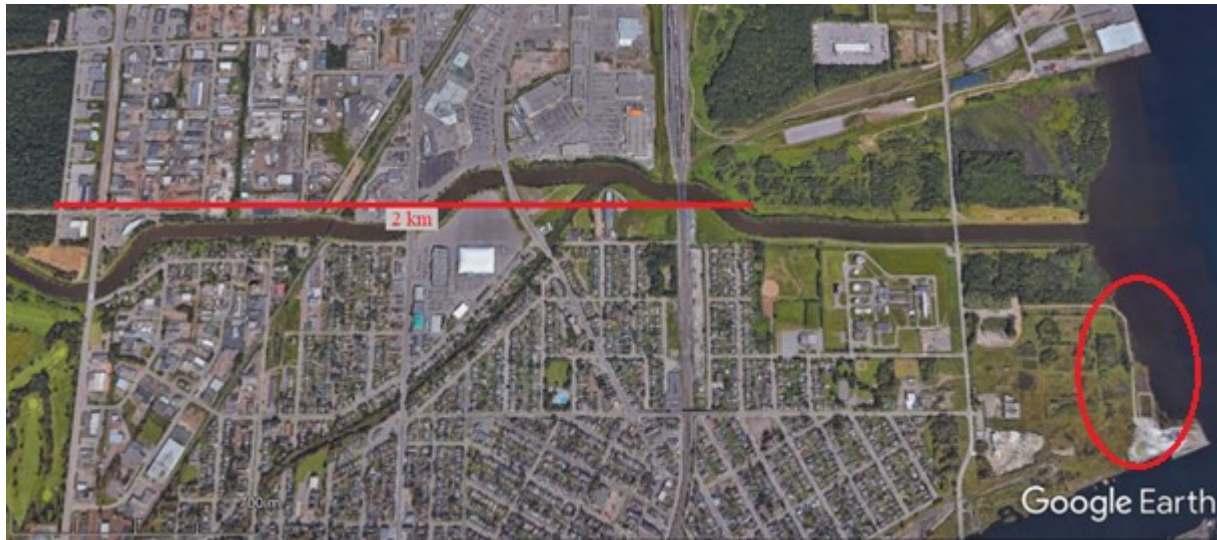
Figure 31: Neebing - McIntyre River Channel Buffer Impedance. (Google Earth Satellite Imagery)

Although there is a vegetation buffer at the river delta, there is approximately 2km of residential housing and industrial property along the upper portion of the river (Figure 31). The large volume of impervious surfaces has likely led to increased runoff into the river system, potentially influencing conductivity, pH, and dissolved oxygen. Additionally, a degree of habitat fragmentation occurs from the roadway to the south of the river that directly lines the waterfront (Figure 31). Even though there is some buffer at the river mouth, the upstream influence affected the final score, receiving a 2 (Appendix 1). These upstream and surrounding habitat influencers should be considered when designing a remedial action plan.

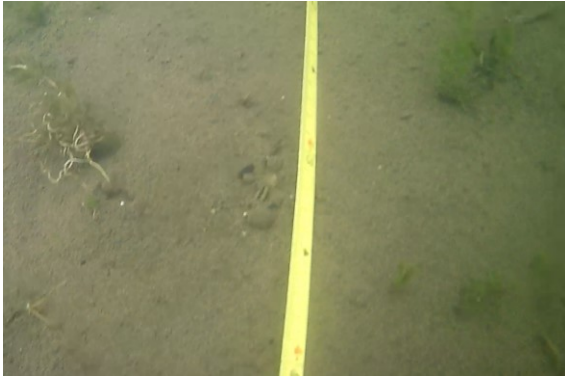
Figure 32: Spring Transect 1 with 1-25% Vegetation Cover.

The first transect had a low volume of vegetation (1-25%) (Figure 32), consisting of only Canadian Waterweed (*Elodea canadensis*), Pondweed (*Potamogeton sp.*) and Crowfoot (*Ranunculus*). These types of vegetation all have a low U-Value and T-Value, indicating that they have a high tolerance to degradation and have a broad niche in which they can survive. These were likely the only species that could root in the coarser sand substrate, while simultaneously receiving high volumes of fetch from the high exposure to the lake. The abundance and densities remained the same in the fall, with only limited new growth (Figure 33). Due to the hydraulic influence of Lake Superior, substrate composition and shallow depth macrophyte success is limited from regular disturbance and limited nutrient availability.

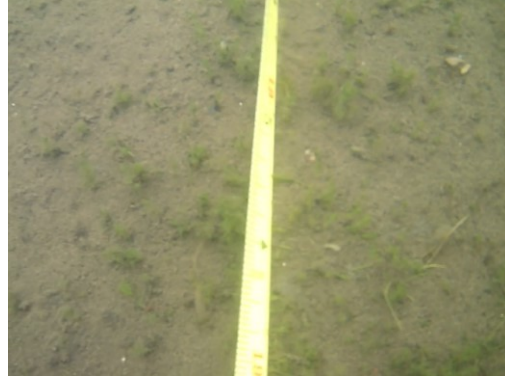
Figure 33: Fall Transect 1 with 1-25% Vegetation Cover.

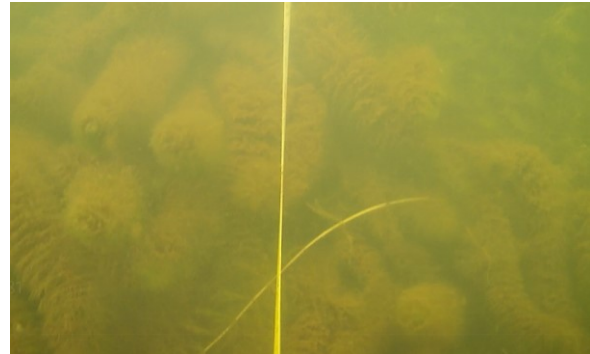
Figure 39: Fall Transect 4 with 75-100% Vegetation Cover.

The final transect was within the next embayment area perpendicular to the shoreline (Figure 40) and had less vegetation coverage in the spring ranging from 50-75% coverage along the transect (Figure 38). Patches of the substrate could be easily seen through the new vegetation growth (Figure 38). Macrophyte coverage increased to 75-100% in the fall as additional growth occurred and existing vegetation grew substantially (Figure 39). The vegetation stand was more homogenous than transect 3, with a top-heavy canopy and lower biomass covering the substrate. The predominant vegetation was Bladderwort (*Utricularia sp*) and Fern-leaf pondweed (*Potamogeton robbinsii*). The vegetation density transitioned near the middle section of the embayment area, becoming sparser, with patches of the substrate showing along the transect. Sedimentation within the embayment promoted growth and reproduction in the early season.

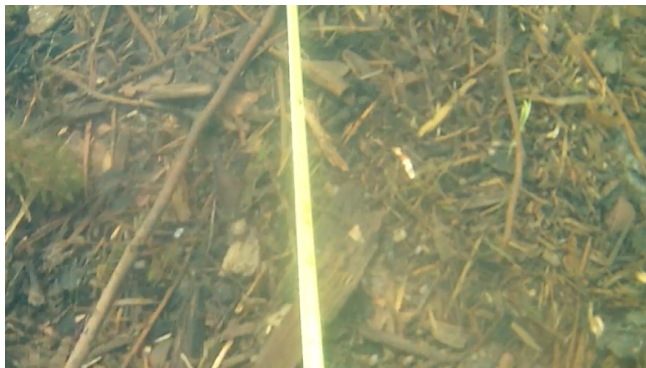
Figure 42: Transect 3, Silty Sand Substrate with a Layer of Woody Debris.

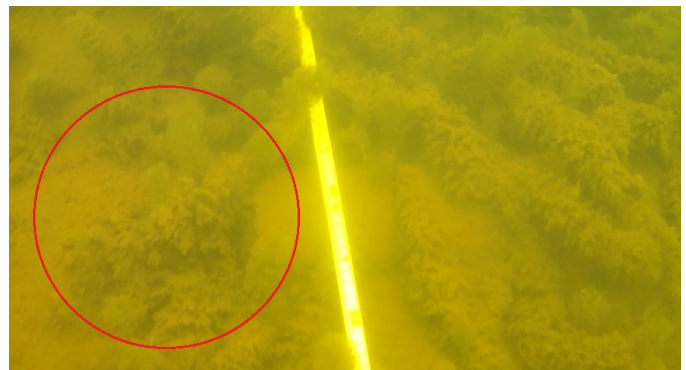
Figure 43: Transect 4, Sedimentation atop of Macrophyte Canopy.

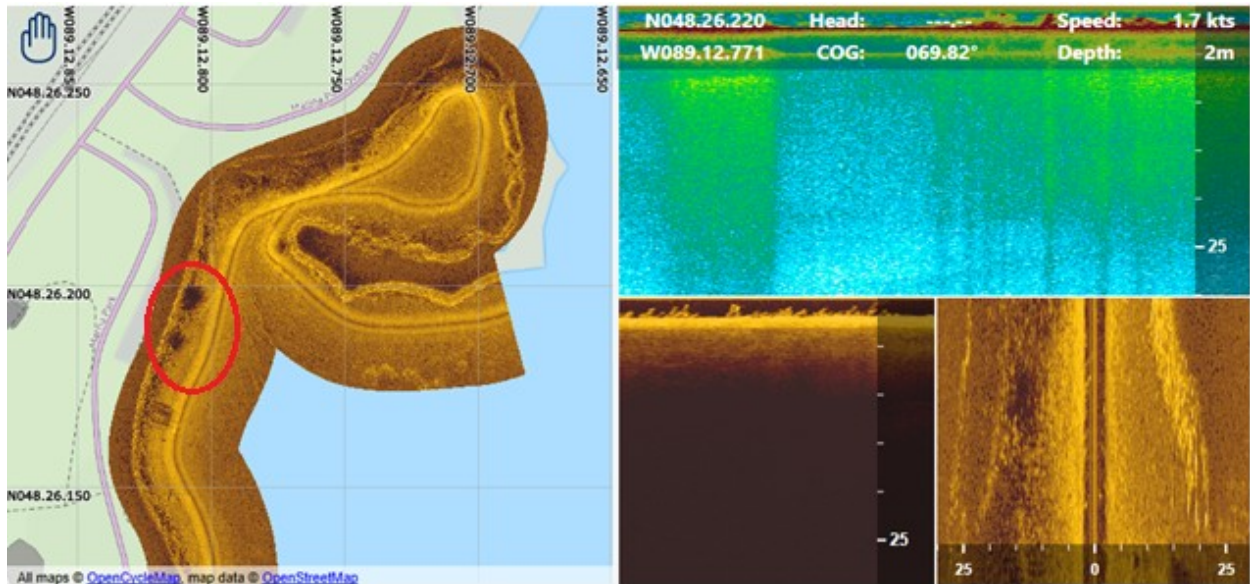
Figure 49: Sanctuary Island Side-Scan Sonar Imagery Depicting Macrophytes along the Cobble Shoal.

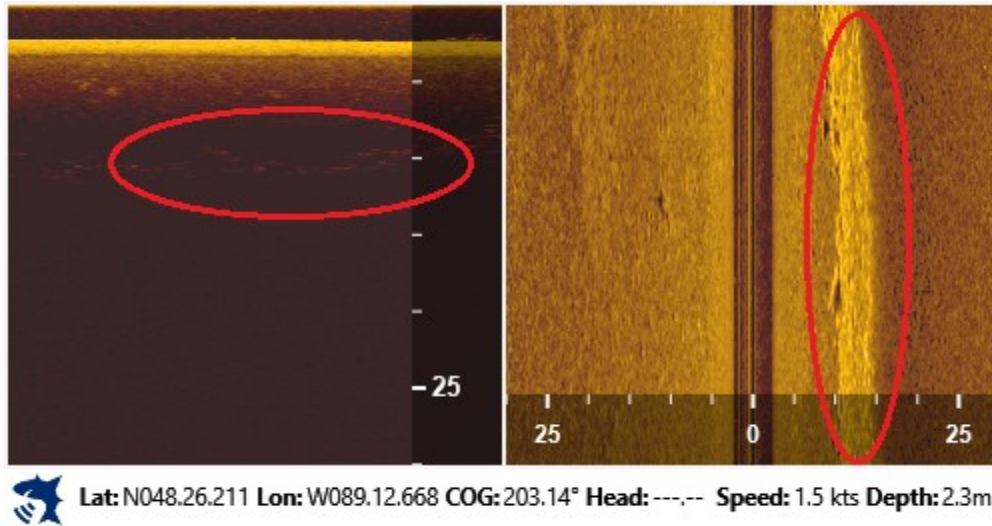
Figure 50: Sanctuary Island Distinct Change in Substrate from Cobble to Sand Substrate.

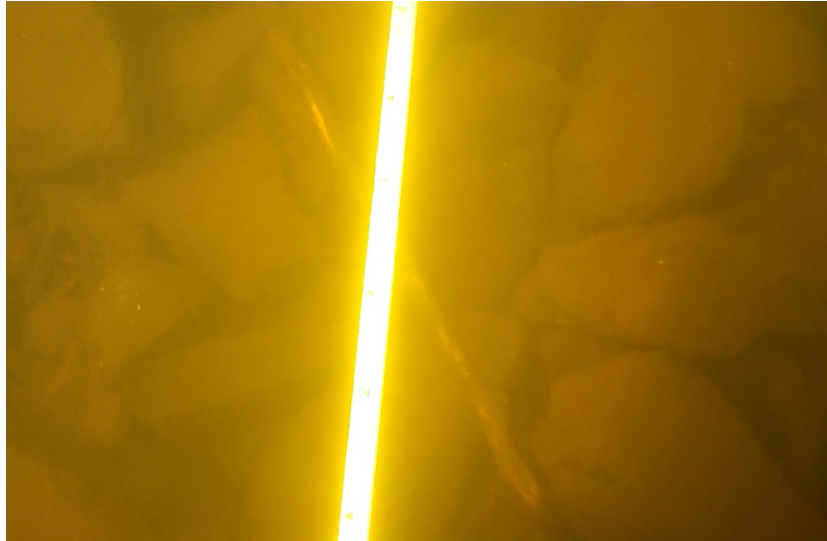
Figure 56: Current River Transect 2 Depicting Larger Cobble Substrate with Darker Water Colour from Tannins Upstream.

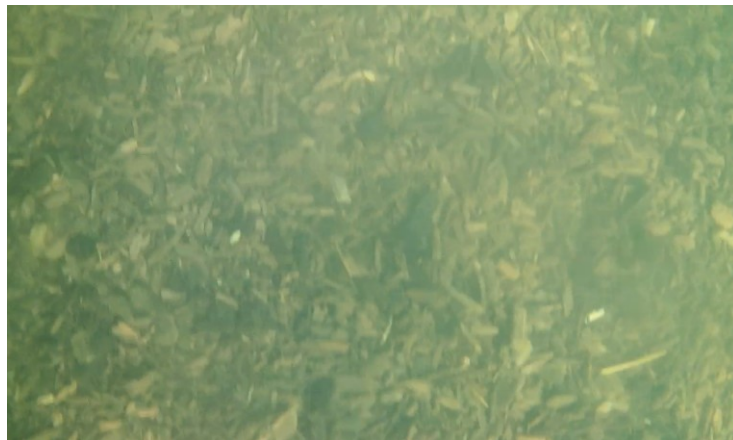
Figure 63: North Harbour Small Woody Debris Outside of the Lagoons.
