Fire Performance of a Novel Concealed Mass Timber Moment-Resisting Connection Utilizing Mechanically-Fastened Steel Rods

A thesis

Civil Engineering

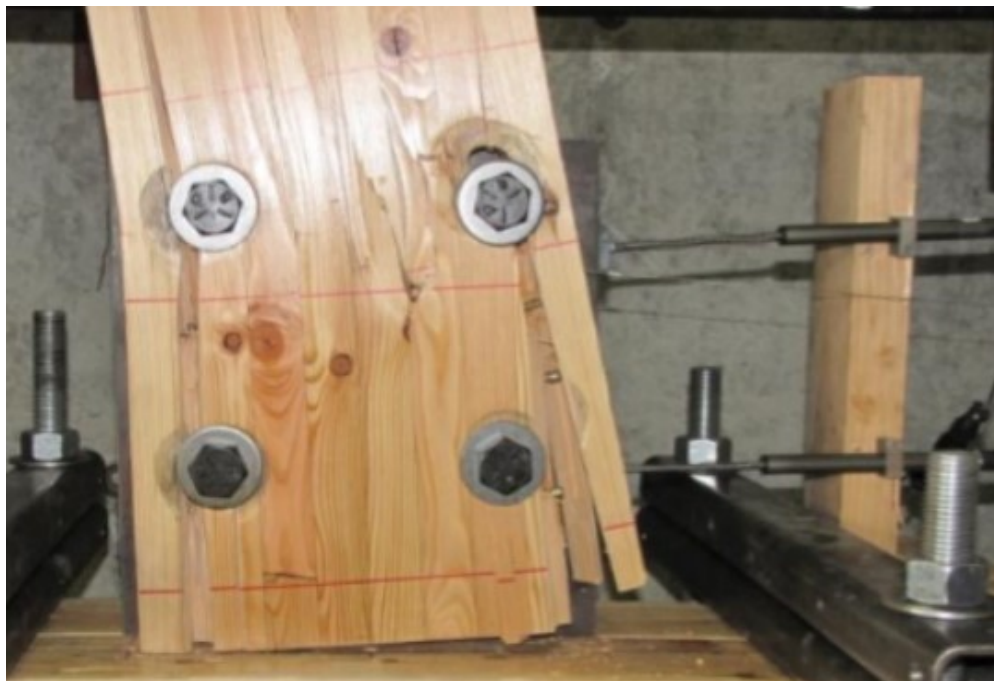
Figure 2.2. Typical failure of a bolted connection with STS (Gehloff et al., 2010)

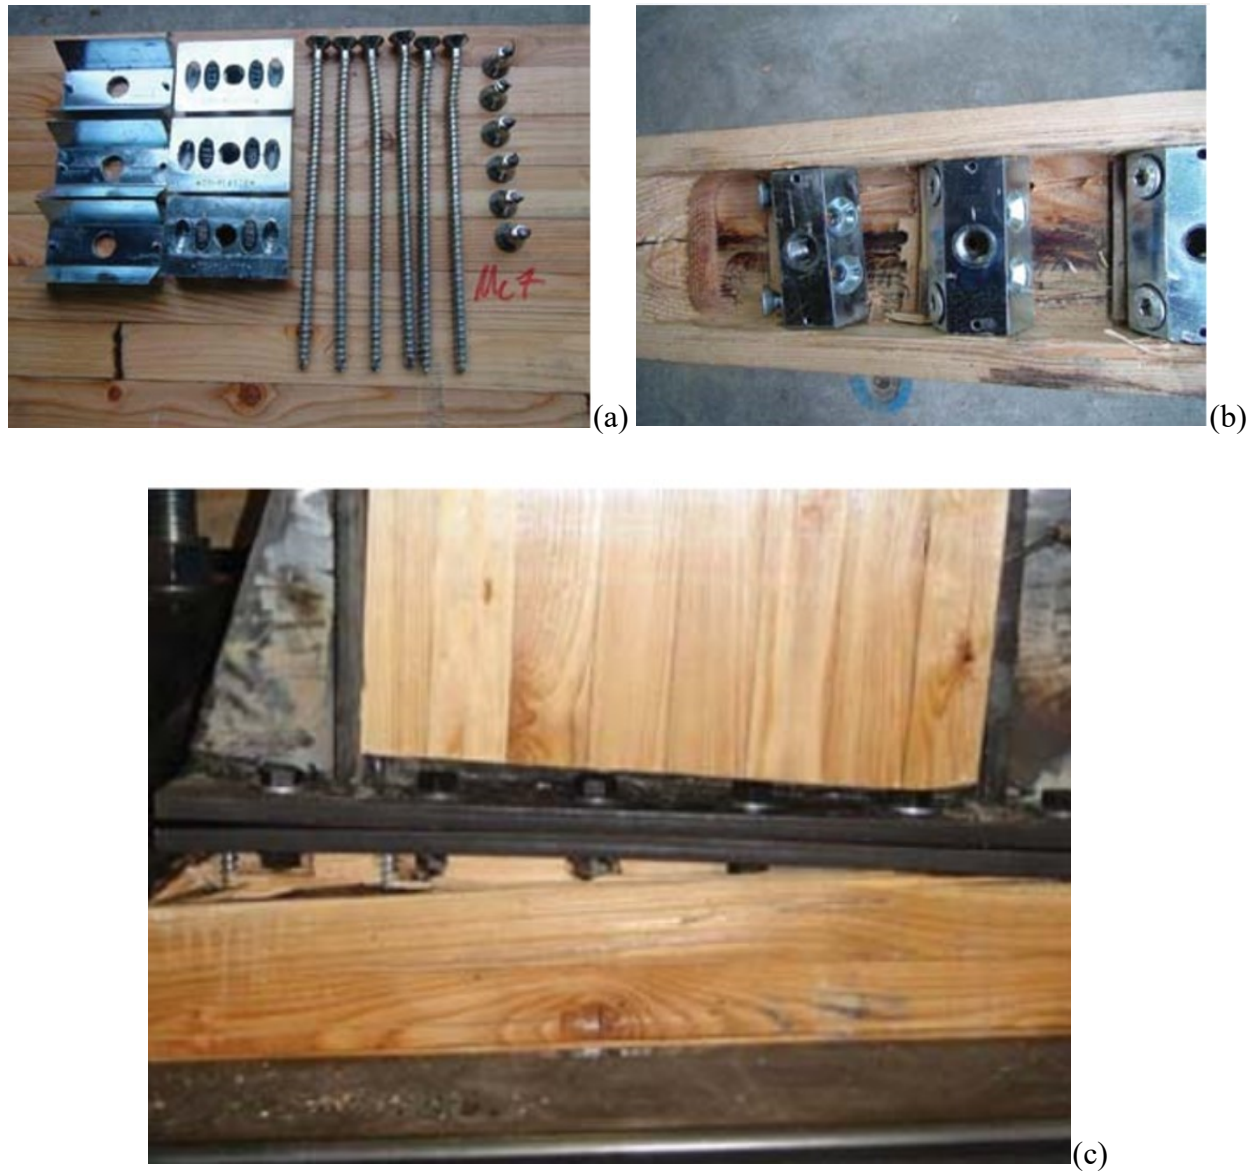
Figure 2.5. Failure modes of self-tapping screw fastening beam-to-column connection: (a) disassembled ZD-plate with compression screws bending and tension screws fractured removed from beam section; (b) disassembled ZD-plate with compression screws bending and tension screws fractured attached to beam section; (c) Screw withdrawal in bottom member (Closen and Lam, 2012).

The average ultimate moment resisting capacity exceeded the design moment capacity of the glulam section by a factor of 2. The main failure modes were tension fracture and withdrawal of screws as shown in Figure 2.5. Even though the connection had a high moment capacity, the

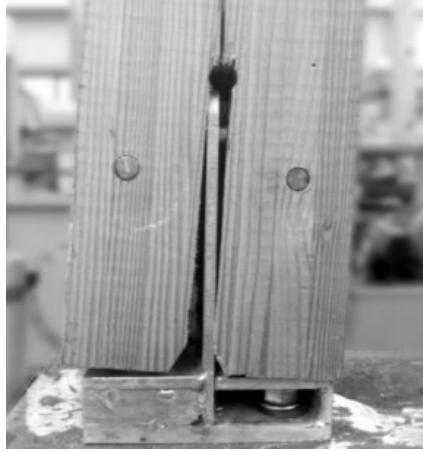
Figure 2.7. Post base joint with concealed connector (Humbert et al., 2014)

Similar conclusions were drawn by Humbert et al. (2014) during their experimental study on the mechanical behaviour of post and beam joints secured with metal fasteners. In their study, they found that although the connection capacity could be increased by increasing the stiffness in the connection steel components, this resulted in brittle failure modes in the wood section before the steel yielded in plastic failure as shown in Figure 2.7. A steel cross plate (+) was inserted into the end of 180 mm x 180 mm Japanese larch glulam posts. The plates that were 6 mm thick had deformation in the steel while the 8 mm thick plates, although did increase moment resistance, had the wood section split. This requires good optimization of the connection design to increase the thickness and stiffness of the steel connecting components enough to just provide sufficient moment resistance without promoting the formation of brittle failure in the wood section before failure occurs in the steel components.

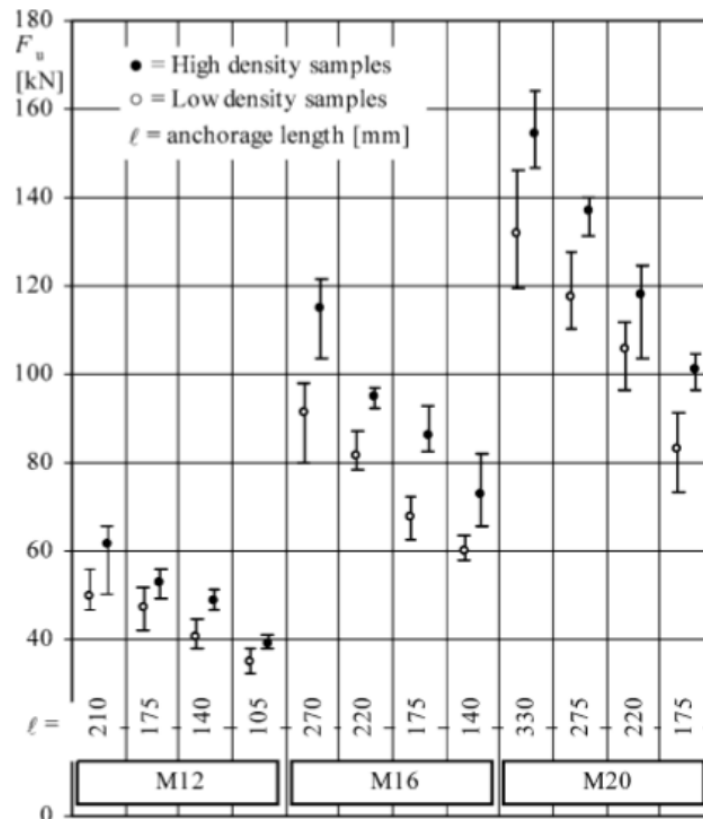
Figure 2.8. Ultimate tension loads for single glued in rod tests (Steiger et al., 2006)

Steiger et al. (2006) completed a glued-in rod tension testing program using a variety of parameters to try and find some consistency between all of the parameters. Norway spruce glulam was used consisting of low and high density samples. Three different rod diameters; M12, M16, and M20; were selected using a class 8.8 steel rod to promote a timber shear failure rather than a steel yielding failure. Each rod diameter had four different rod embedment lengths as well in relation to the timber and steel, and their corresponding area and modulus of elasticity to give the joints an optimal performance. The results of all of the tests are presented in Figure 2.8.

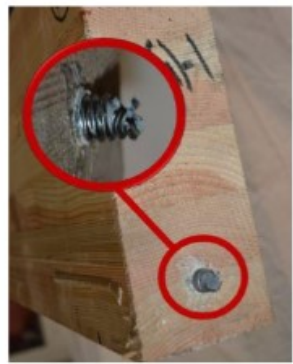
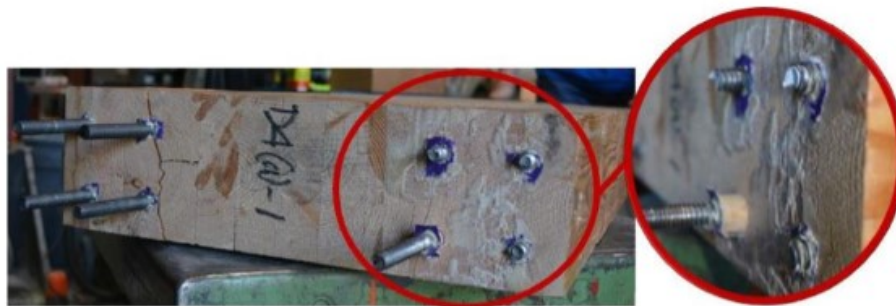
Figure 2.11. Ductile failures of glued-in rod moment connections: (a) A1(a); (b) B2(a); (c) C3(a); (d) D2(a); (e) D4(a) (Oh, 2016).

As predicted from the recommendations, all of the tests with the shorter embedment length experienced rod pull-out, while the tests with the longer embedment length mainly experienced tension failure in the steel. Figure 2.11 shows the ductile failures that were observed by every configuration with the longer embedment length.

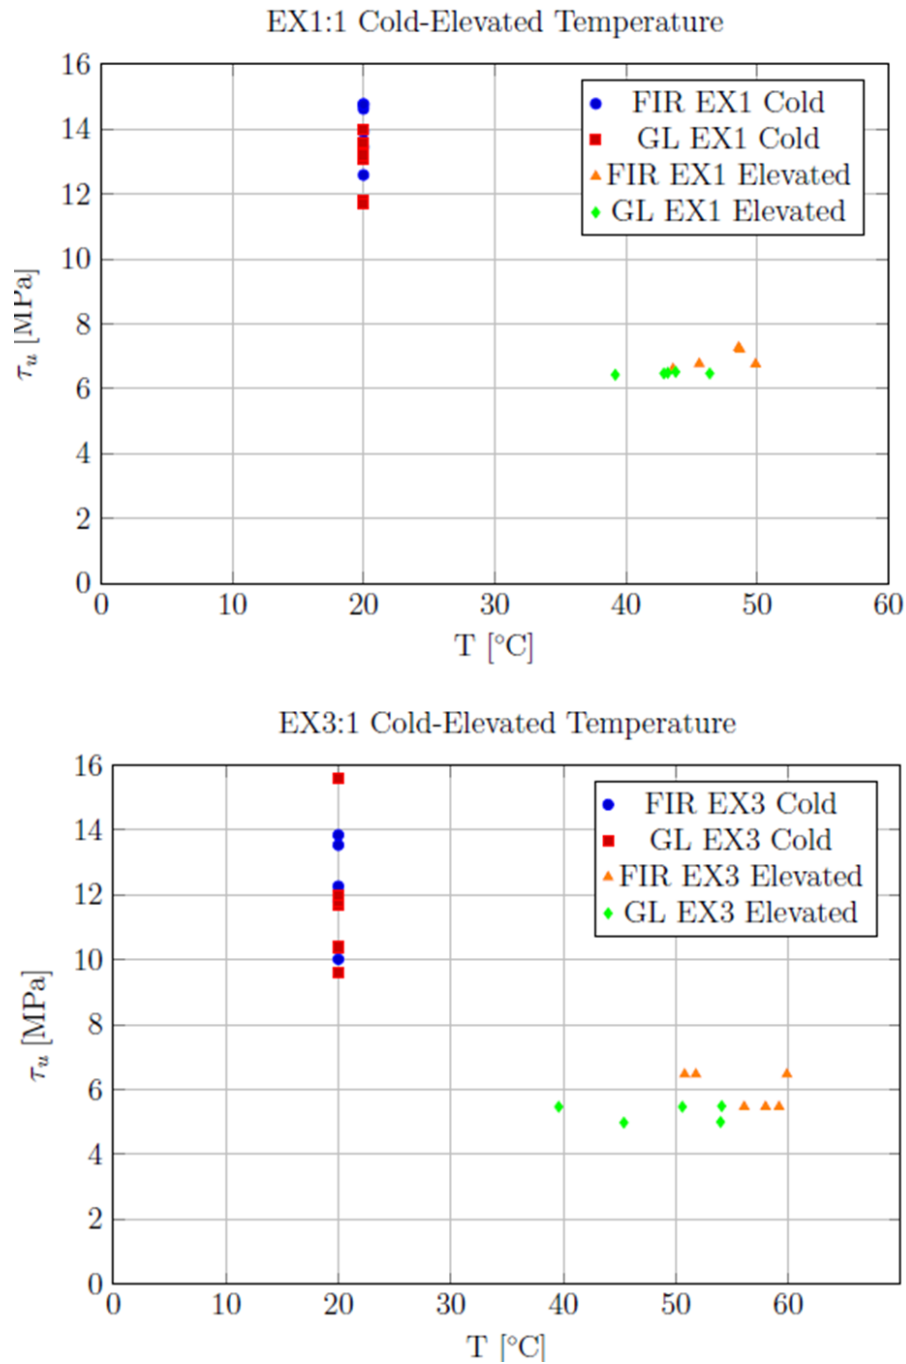
Figure 2.14. Shear strength versus temperature of tension connections at ambient and elevated temperatures (Di Maria et al., 2017)

testing a single steel rod under tension in the end of spruce glulam and solid sawn Douglas fir. Half the shear strength at ambient temperature testing was chosen as the design load for the elevated temperature testing. Figure 2.14 shows the connections failing at temperatures between 40 and 60°C in the epoxy for the two different viscosities.

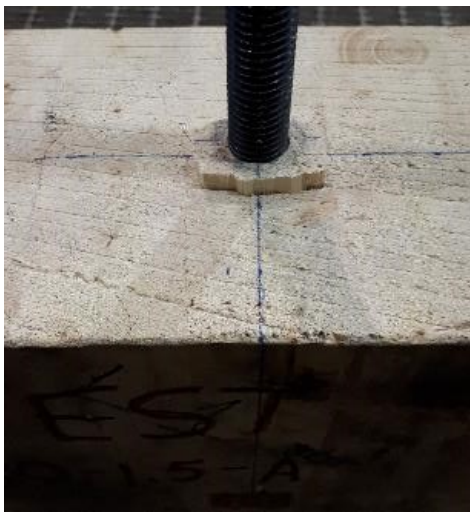
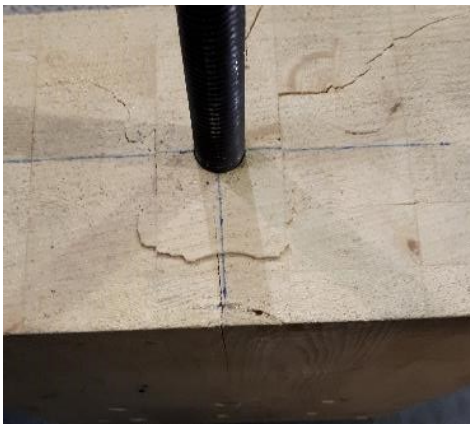
The desirable failure mode was rod pull-out as shown in Figure 3.5. In Figure 3.5(a), the failure was a rod pull-out of a square area of a similar size of the utilized washer. In Figure 3.5(b), the failure was similar to that shown in Figure 3.5(a) except that instead of shearing along the fourth side of the washer closest to the small hole, the wood surrounding the rod sheared along the three walls of the small hole that was chiselled out. In Figure 3.5(c), the failure was similar to that shown in Figure 3.5(b), except that one or two 45-degree cracks also formed on the end surface at approximately where the washer corners were.

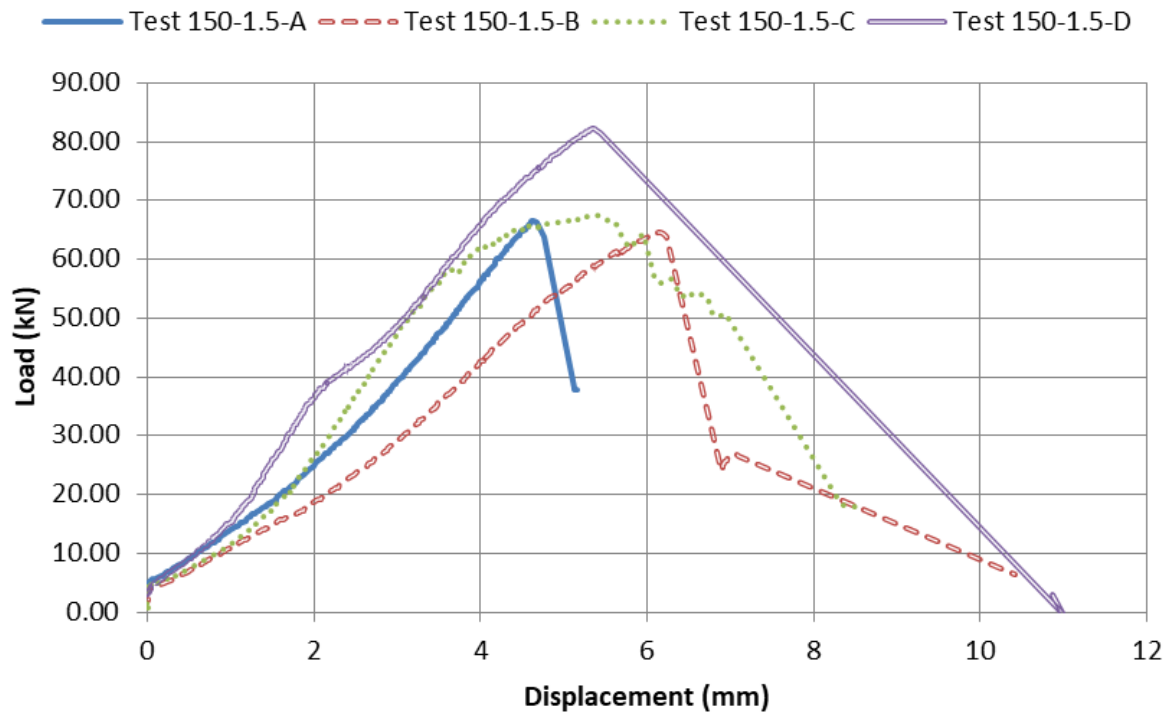
Figure 3.10. Load-displacement relationships for Test 150-1.5 connections

Figure 3.10 show the load-displacement relationship for Test 150-1.5. All tests show a steady increase in load sustained before a sharp drop, except Test C, which follows the trend of a rod pull-out failure. Test C experienced a few millimeters of wood crushing before experiencing the final rod pull-out failure.

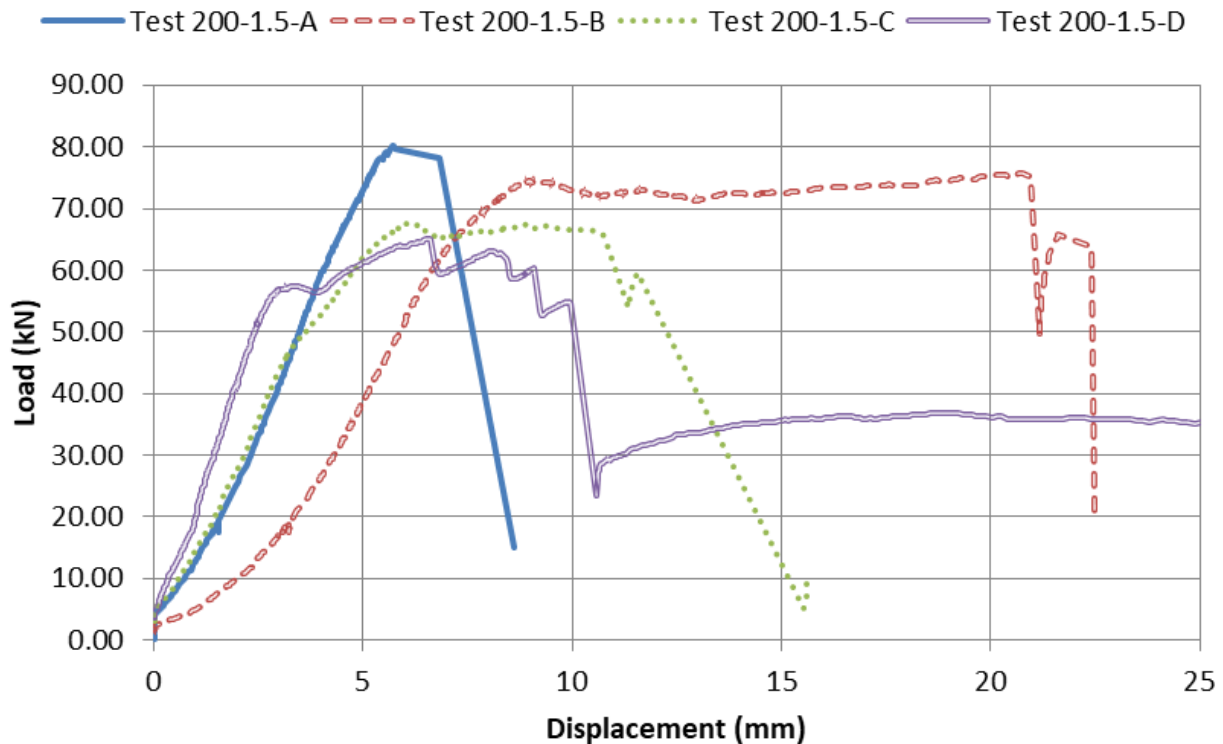
Figure 3.11. Load-displacement relationships for Test 200-1.5 connections

Figure 3.11 shows the load-displacement relationships of the connection configurations of Test 200-1.5. Only test replicate A experienced sudden failure of rod pull-out, similar to the failure developed in the connection configurations of Test 150-1.5. The other test replicates experienced crushing of the wood section, similar to the failure developed in the connection replicate C of Test 150-1.5, and at around the same failure load of 65.0 kN. Also, the wood crushing was experienced for much deeper in the wood section compared to the 3.0 mm experienced in the connection replicate C of Test 150-1.5, by up to 15.0 mm. This extended crushing is because the connection configuration of Test 200-1.5 has an extra 50 mm of length to hold the wood at this failure load before experiencing rod pull-out failure.

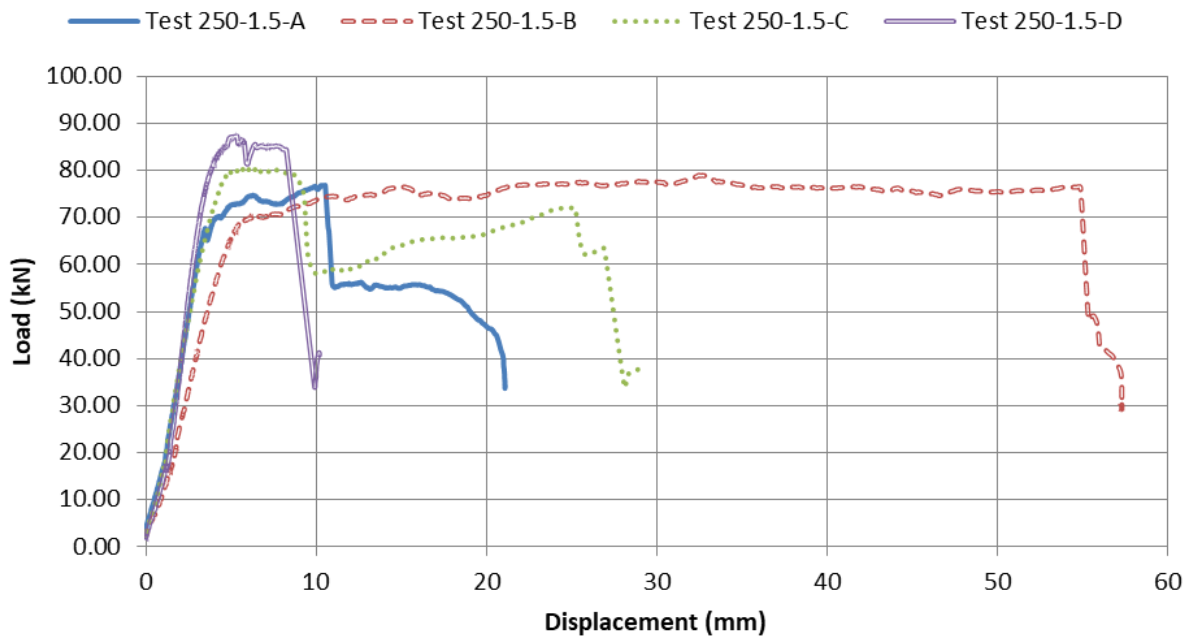
Figure 3.12. Load-displacement relationships for Test 250-1.5 connections

Figure 3.12 shows the load-displacement relationships of the connection configurations of Test 250-1.5. All four test replicates experienced crushing of the wood to some degree before experiencing a splitting or rod pull-out failure. These four replicates of Test 250-1.5 experienced wood crushing at a slightly greater load of about 70.0 kN compared to that of Test 200-1.5 replicates. The extra 50 mm of length in Test 200-1.5 replicates helps the wood section to hold this crushing failure for even longer, by up to 50 mm before experiencing the final failure.

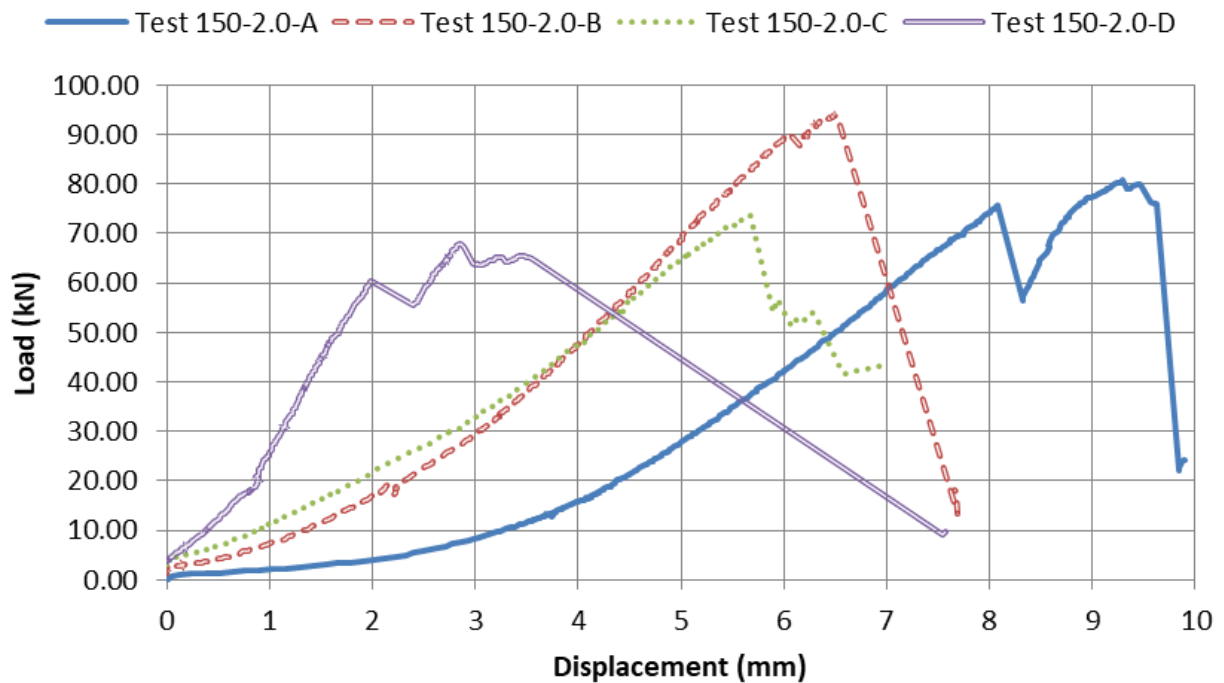
Figure 3.13. Load-displacement relationships for Test 150-2.0 connections

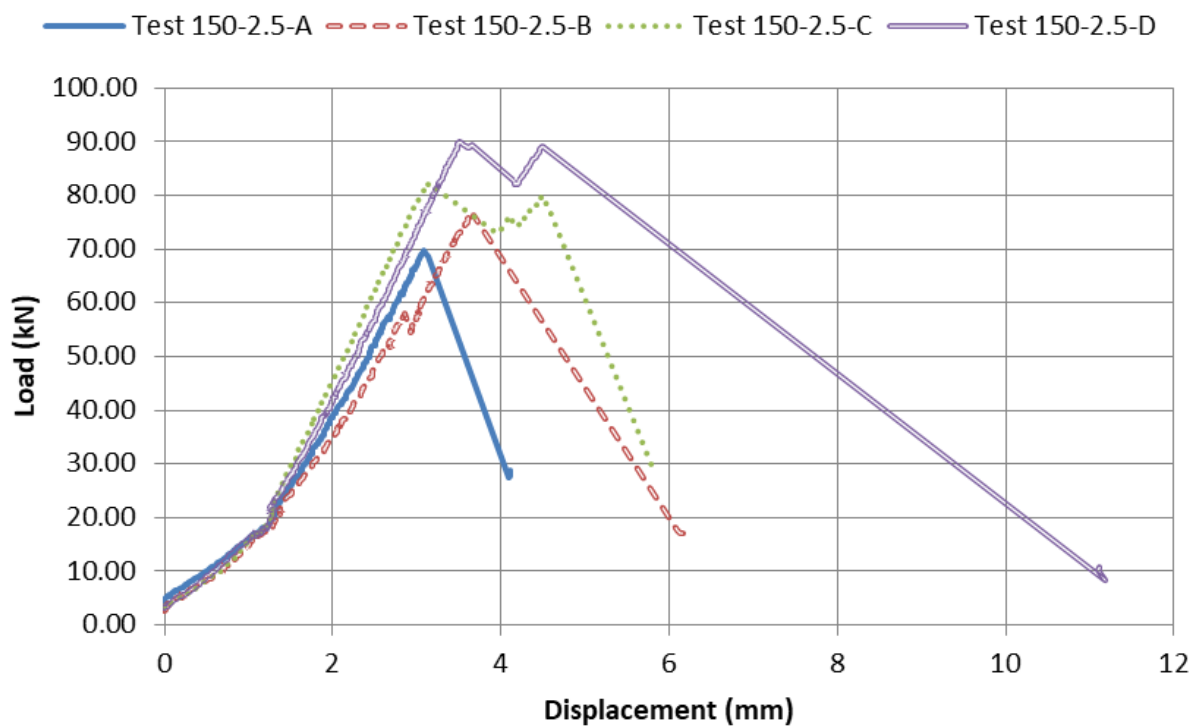
Figure 3.16. Load-displacement relationships for Test 150-2.5 connections

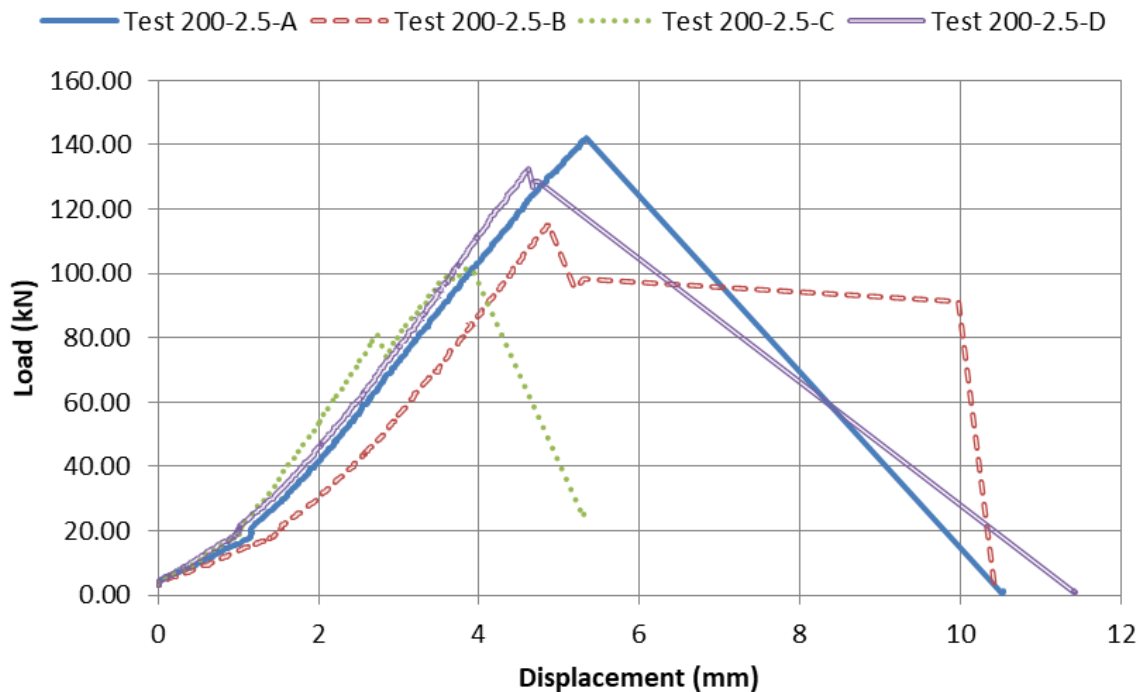
Figure 3.17. Load-displacement relationships for Test 200-2.5 connections

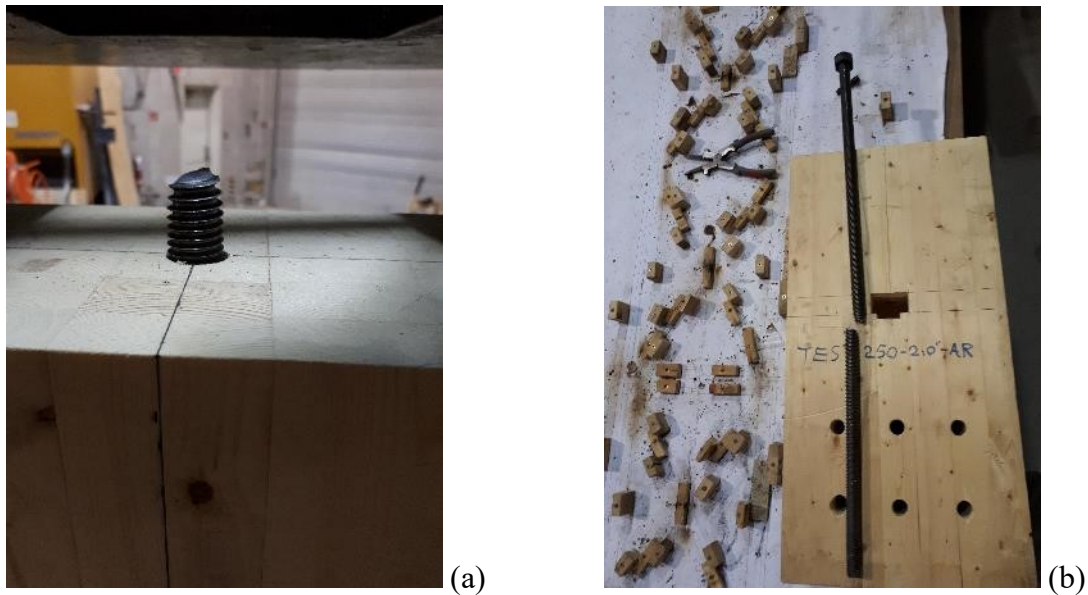
Figure 3.22. Yielded steel rod and non-deformed glulam section: (a) Steel rod broken in glulam; (b) Fractured steel rod.

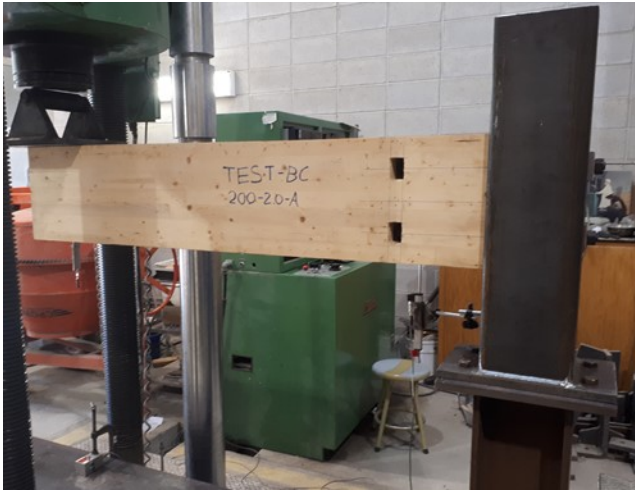
Figure 4.4. Full test setup of a general beam-column connection test assembly: (a) Full test assembly diagram; (b) Front side of assembly setup; (c) Back side of assembly setup.

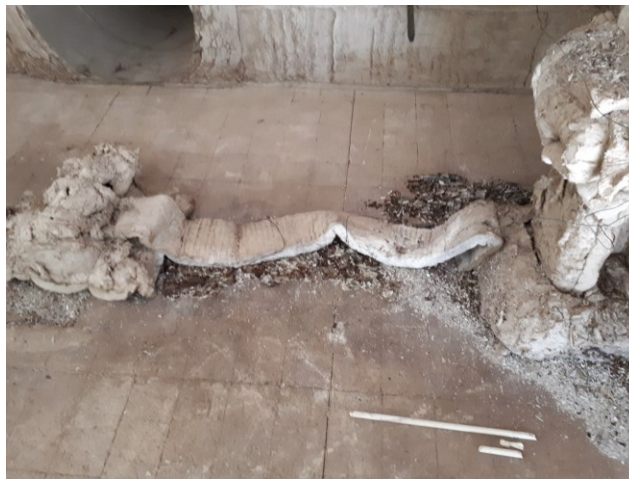
Figure 5.6. Fire tested beam upon completion of testing
