**MONITORING FOR SUCCESS IN STREAM RESTORATION: A CASE STUDY OF  
THE KAMA CREEK, NORTH SHORE OF LAKE SUPERIOR**

A Thesis Submitted to Lakehead University in Partial Fulfillment of the  
Thesis requirements for the degree of  
Master of Environmental Studies in Northern Environments and Cultures  
in the departments  
of  
Anthropology and Geography

May 2015

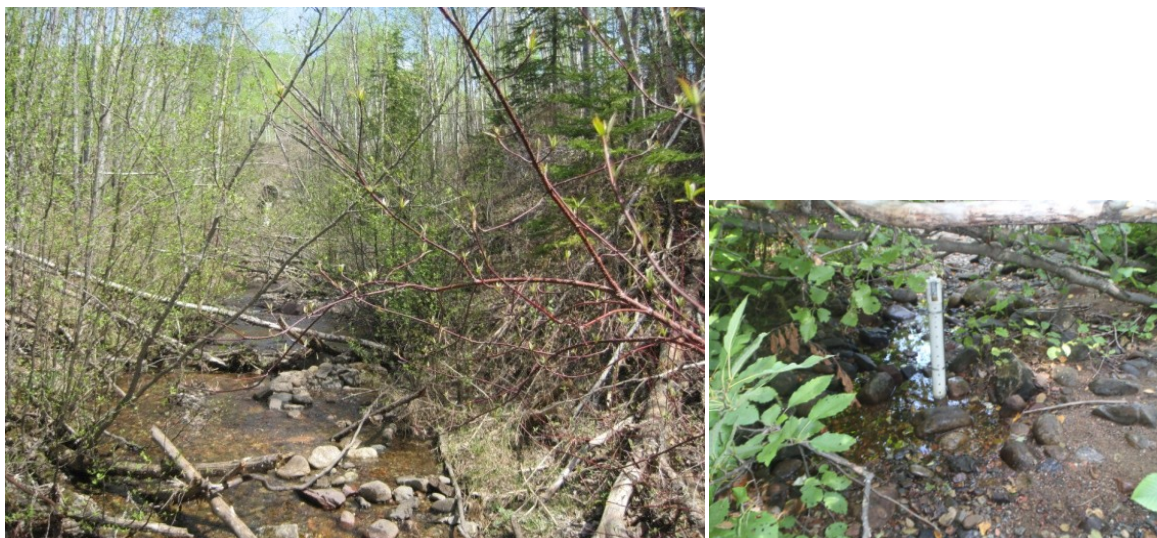
Figure 3.2. Photo of reach 1, (left) the old straightened channel, and location of site 1, (right) within reach 1 near the culvert below the railway.

Prior to restoration activities, the focus of the baseline data was placed on reach 1 (site 1) in 2011. This is the portion of the stream that was diverted in the 1960s and where fish passage was cut off at the railway culvert (See Figure 3.2). A second reach, reach 3 (site 3), was also established above the culvert to determine the presence of fish before and after restoration, and to act as a reference for discharge measurements for all years of the survey. Post restoration data (2012 and 2013) in the restored portion of the creek below the culvert was established as reach 2 (site 2).

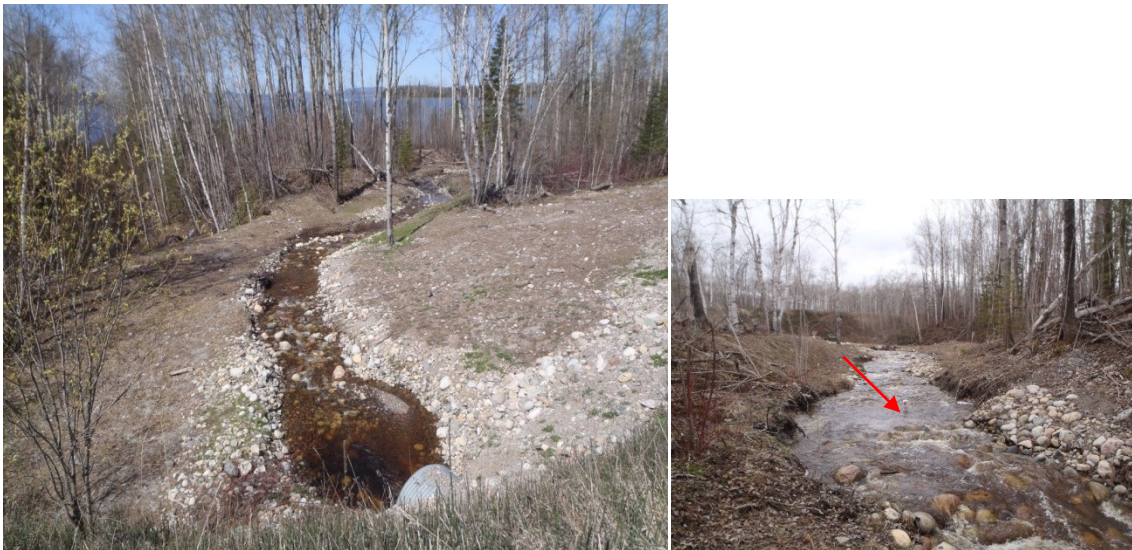
Figure 3.4 Photo of reach 2 (left) and location of site 2 (right) within reach 2, arrow pointing to level logger where data was collected.

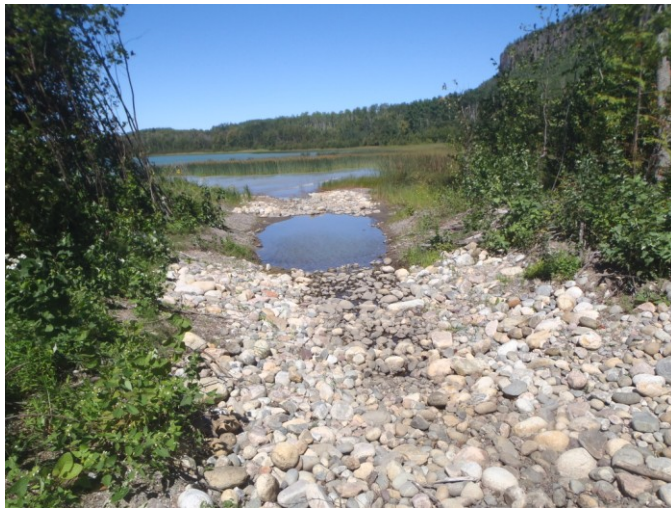
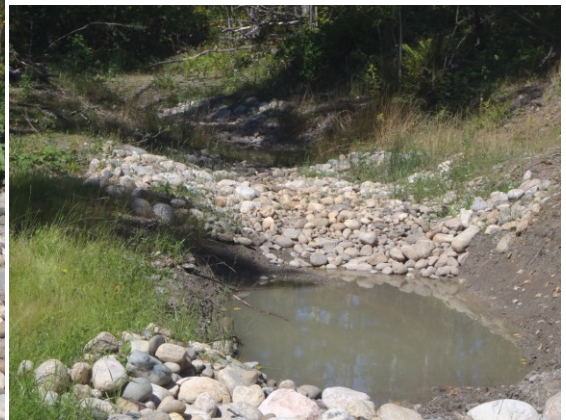
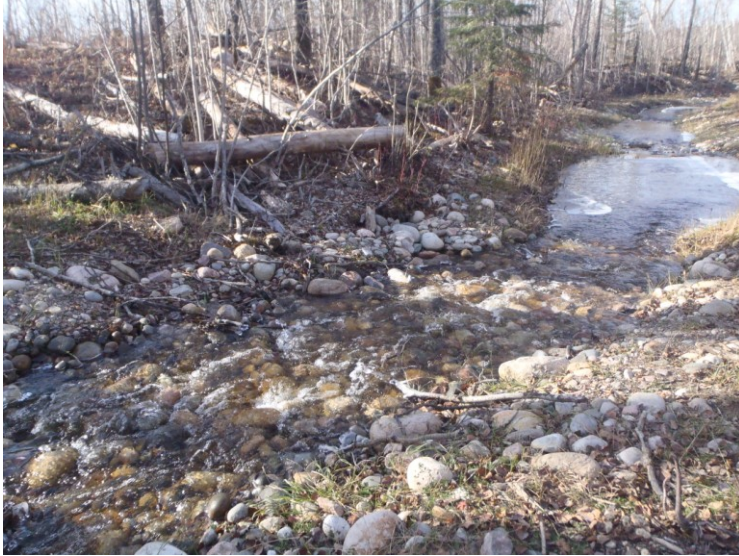
because the restored channel in 2012 could be estimated from the design specifications and the known percentages of cobble used in the construction activities. Photos were taken (Figure 4.6) and visual observations were made on the newly restored channel (reach 2) to ensure these design specifications of pebble to boulder size are consistent throughout the newly restored channel. The proposed substrate sizes in the original design, for the new channel consisted of very coarse-grained particles with the following dimensions and mix proportions:

Figure 4.6 Photos of the restored channel showing substrate size and type present.

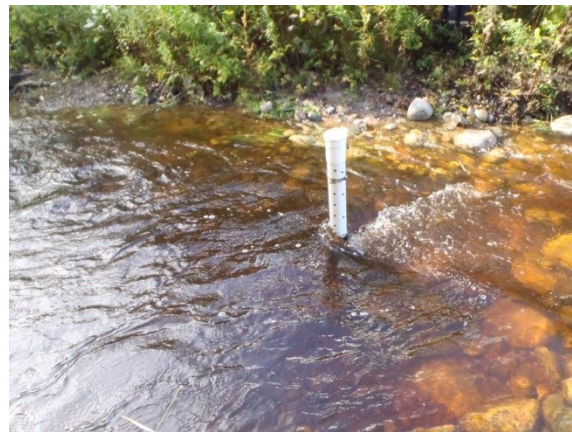
Figure 4.8b. Reach 3, shows a mixture of large deep small shallow and small-deep pools.

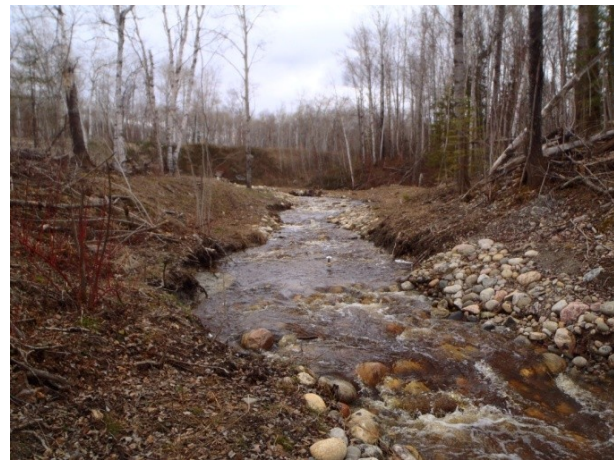
Figure 4.12b. Optimal occurrence of riffles in new channel.

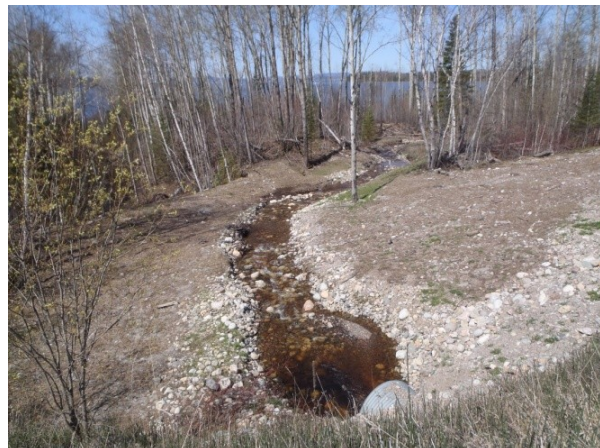
Due to geological control, gradients are steep and highly variable along the Kama Creek system (Clearwater and Kama Creek Study and Restoration, MNR). The steep grade likely accounts for the low channel sinuosity seen in Kama reach 1 which ranked marginal for channel sinuosity (See Table 4.11). The bends in the stream only increase the length of the stream by 1 or 2 times (See Figure 4.13a). The newly restored channel has a high degree of sinuosity and ranked optimal because the bends in the stream increase the stream length 3 to 4 times longer than if it was in a straight line. This feature is a result of the design which followed the natural channel which existed pre 1960s. This natural meander pattern is shown in Figure 4.13b.

Figure 4.13b. New channel in 2014, constructed in pre 1960's 'natural' channel.

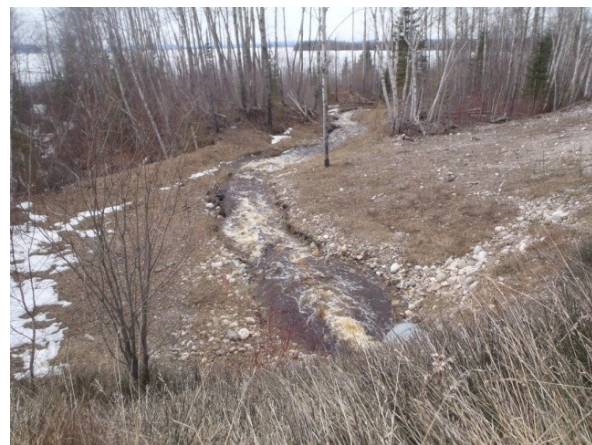
The vegetative zone serves as a buffer to pollutants entering a stream from runoff, controls erosion, and provides habitat and nutrient input into the stream. The Riparian zone width for reach 1 is ranked marginal in Table 4.14 as there are cottages directly to the left bank of the channel but has little human impact (Figure 4.16a). The width of riparian vegetation is approximately 6 meters on the left bank and only slightly more on the right bank. Reach 2 (Figure 4.16b) is ranked suboptimal in Table 4.14 for its riparian vegetation zone width (12-18 meters) and because it has not been impacted, or only minimally impacted, post restoration.

Figure 4.16b. Wide riparian zone with minimal human activity or impact.

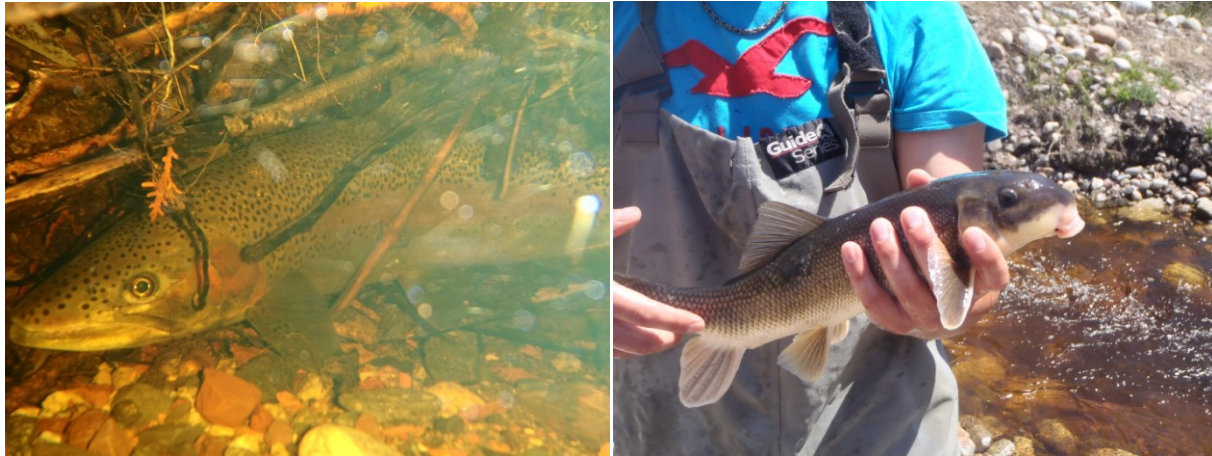
Figure 4.18. Rainbow Trout spotted above the culvert in Reach 3 of Kama Creek in May of 2013, and a common white sucker at culvert in new channel. Photo taken May 27, 2013.
